### Cleanup Update

# Milltown Reservoir Sediments Superfund Site

Issue #78

April 15, 2009

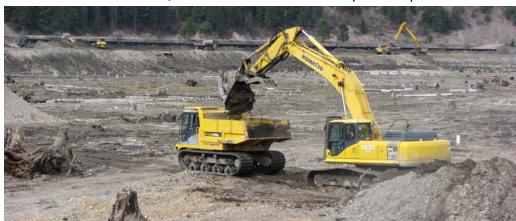
- As of Sunday, just over 2,300,000 tons (~1,769,231 cubic yards) of sediment have been excavated, loaded and hauled off-site. This portion of the project is 80% complete. Removal, loading, and hauling of the contaminated sediments should be complete in early fall.
- Excavating sediments from along the northern edge of the rail loading pad, at the base of the old spur haul roads, and from isolated piles on the original flood plain of SAA-I (Sediment Accumulation Area). Please also notice the stumps in the photo below.
