Cleanup Update

Milltown Reservoir Sediments Superfund Site

Issue #81

May 27, 2009

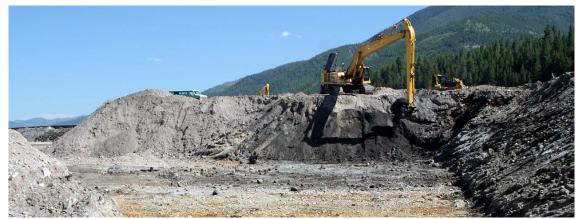
and hauling of the contaminated sediments should be complete by September 2009.
Contaminated sediment excavation continues from the rail loading pad. (photo below taken by Kris Cook, Envirocon, 5/26/09).
