Milltown Reservoir Site Update, January 29, 2008

Removal of the Milltown Dam's powerhouse began yesterday.

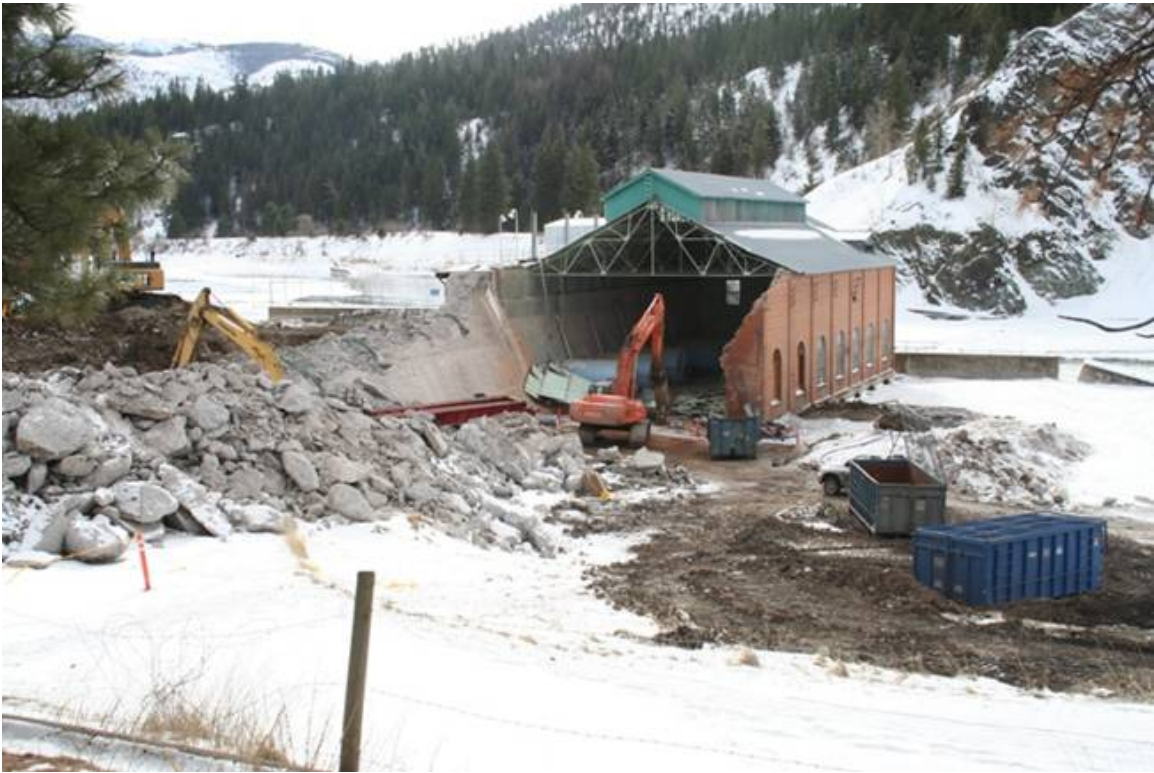
The north wall of the powerhouse was removed yesterday. The first section of the building's roof was removed this afternoon. The orange excavator in the photo above is separating sections of sheet metal roofing from underlying roofing. The concrete rubble at the left side of the photo is from the dam's north abutment.

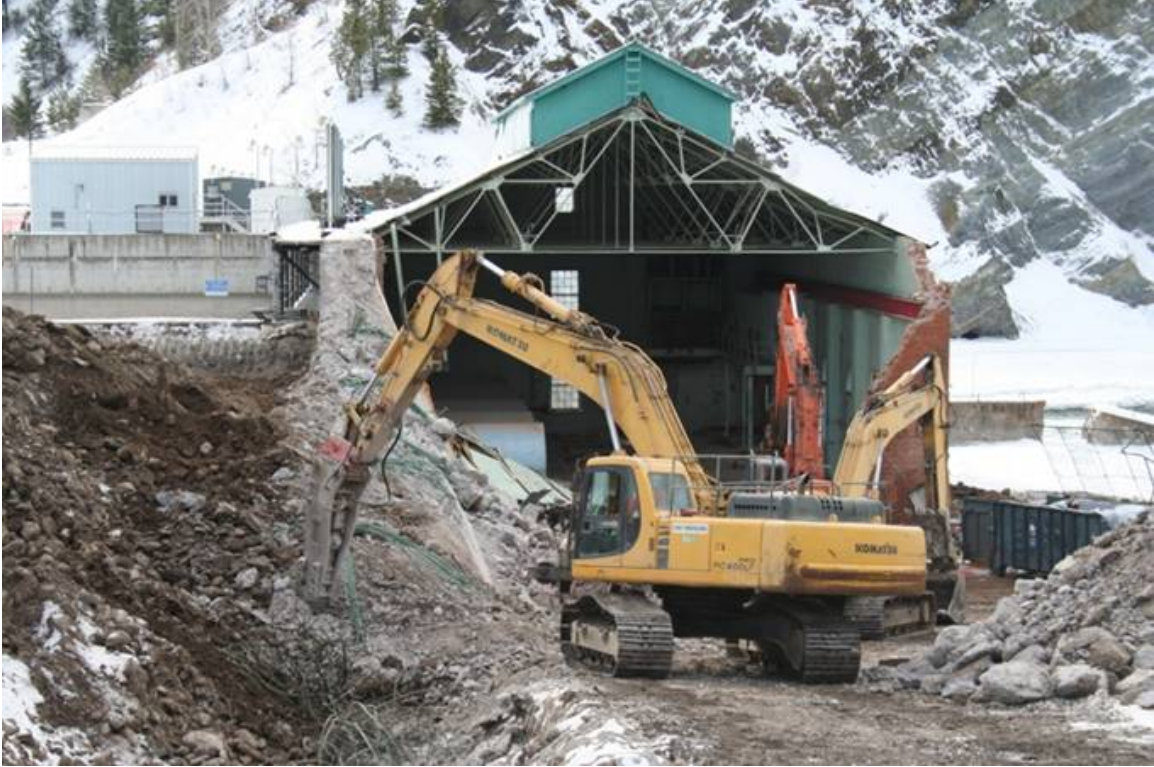
The excavator in the foreground of the photo above is using an impact hammer to break up the concrete of the north abutment wall, which was constructed in 1930 to replace the original timber crib dam upstream of the concrete wall. Some of the timbers removed so far have been rotten, but a few have been in usable condition and have been salvaged. The green cables were installed in the concrete wall during repairs in the 1980's, tied into bedrock to improve dam stability. The concrete in this section of the dam was not reinforced by rebar, but included steel rails and sheet piles for stability. Envirocon has made steady progress in removing the 244 foot long north abutment wall, which is more than one third of the total length of the Milltown Dam. When this section of dam is completely removed, excavators will continue removing the concrete headwall of the powerhouse. When the powerhouse brick walls and concrete headwall are completely removed, 55% of the dam's total 668 foot length will be gone. In late March, the river will be channeled through the opening created by the removal of the north abutment and powerhouse. For the first time in one hundred years, fish will be able to swim upstream past the Milltown Dam.

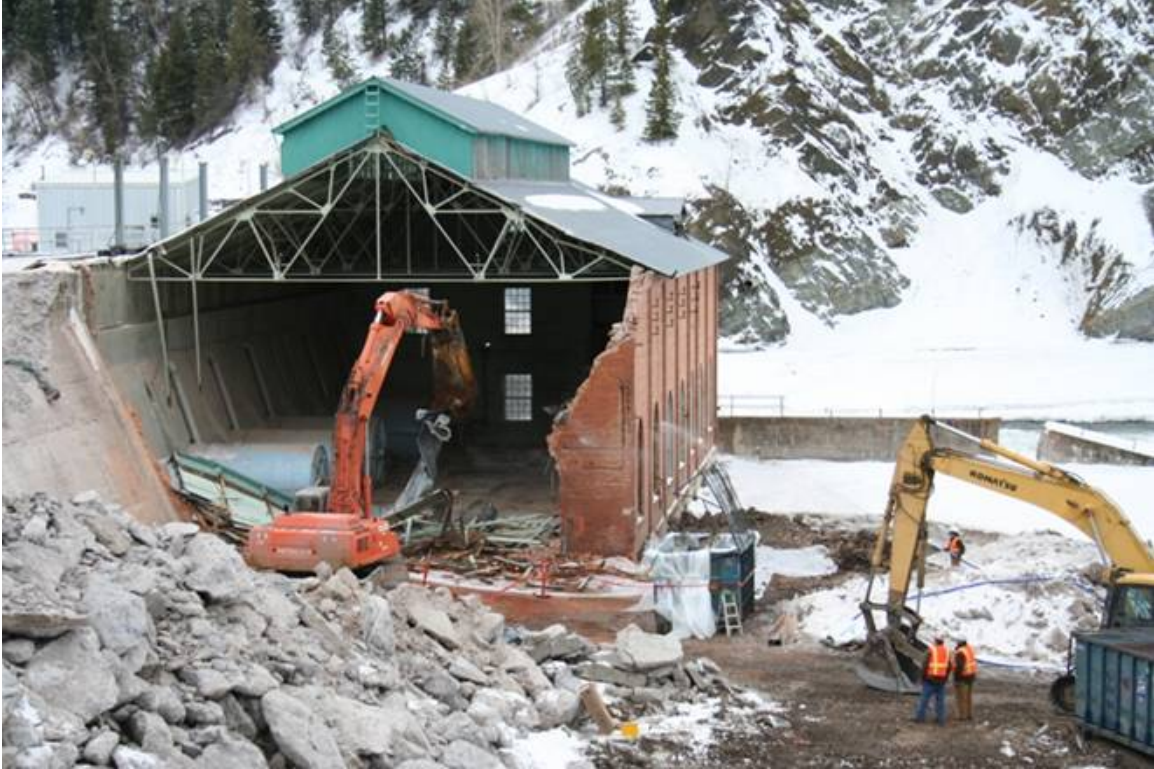
The powerhouse is a three-sided, un-reinforced brick structure, with a concrete headwall that serves as an integral portion of the dam. The powerhouse and dam were built by William Andrews Clark, one of the Butte Copper Kings, who owned a lumber mill where the Bonner Truck Plaza is currently located. The dam provided power to the mill, which provided timbers and fuel for the mines and smelters in Butte, and railroad ties for the trains that hauled ore from the mines. In this photo a worker is spraying water to reduce the chance that small amounts of asbestos in the roofing will be released during its removal.

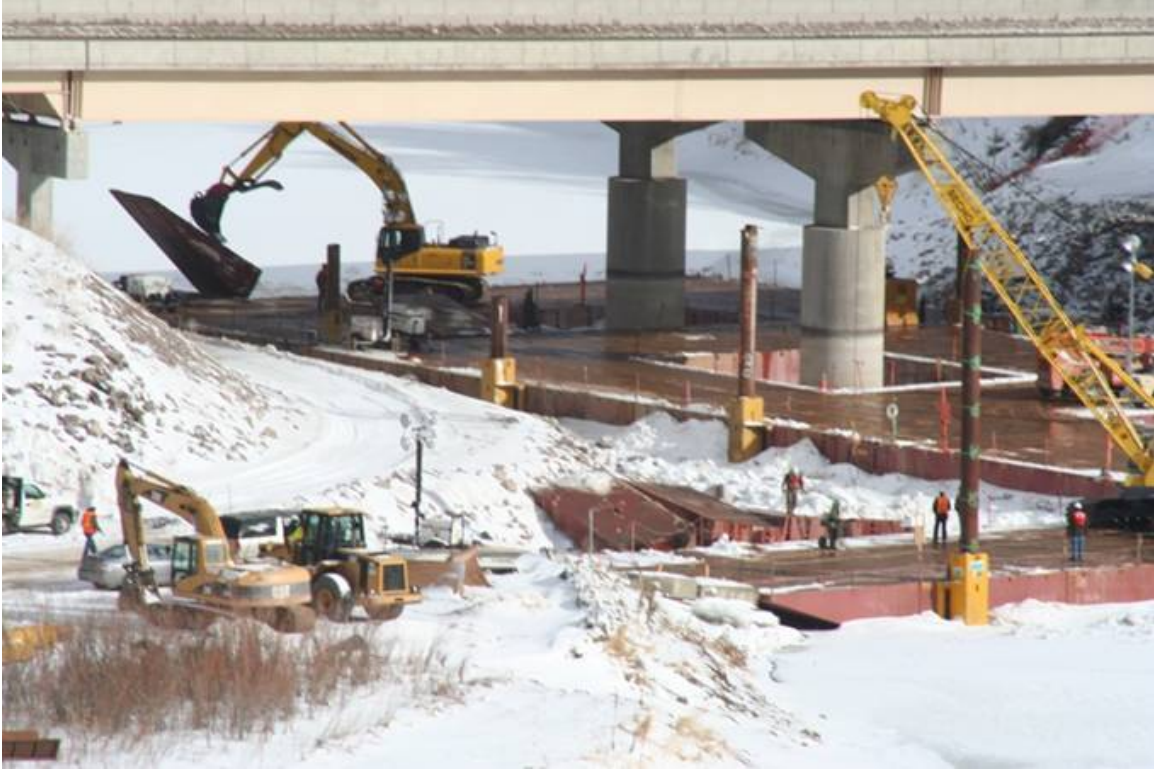
While work continues at the dam site, workers are beginning to remove the barges from the Blackfoot River that were used during the upgrade of the Interstate 90 center piers. The pier stabilization work is complete, and the barges will be removed during the next several weeks.

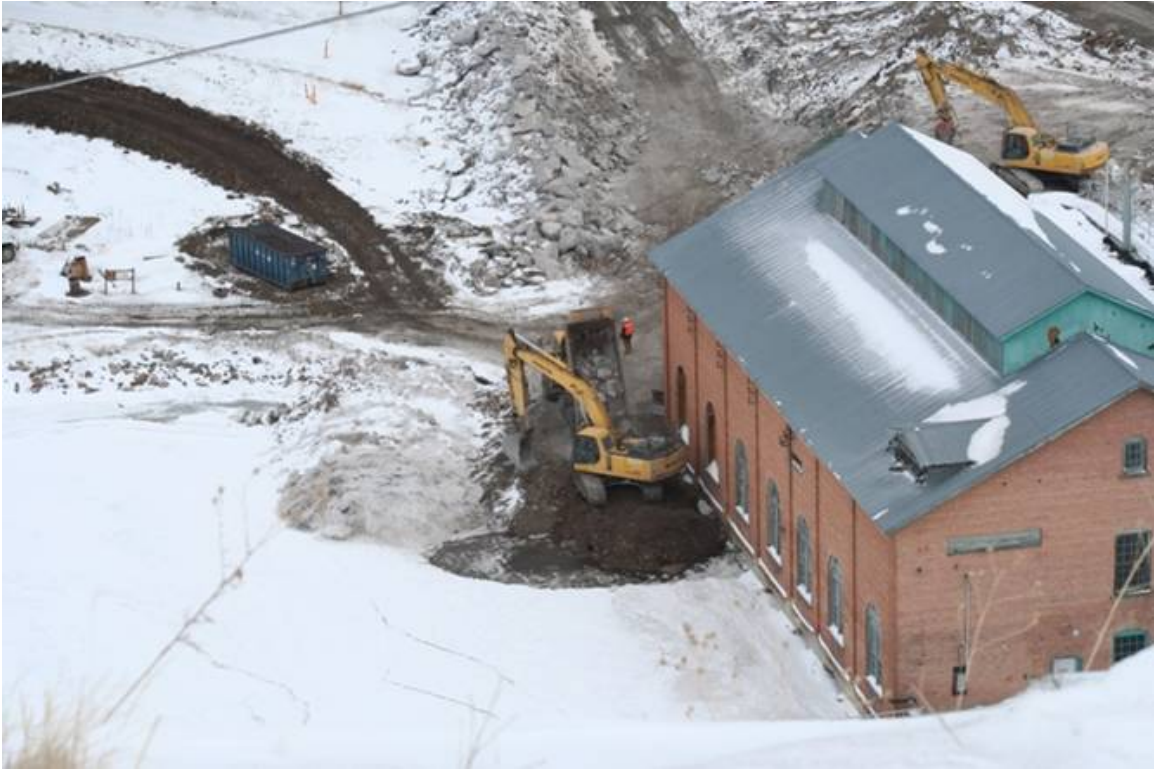
In the photo above, taken yesterday from the bluff overlooking the dam, an excavator is building a work pad downstream of the powerhouse that will be used during its demolition. The work pad will also keep water in the river below from flowing back into the excavation area.

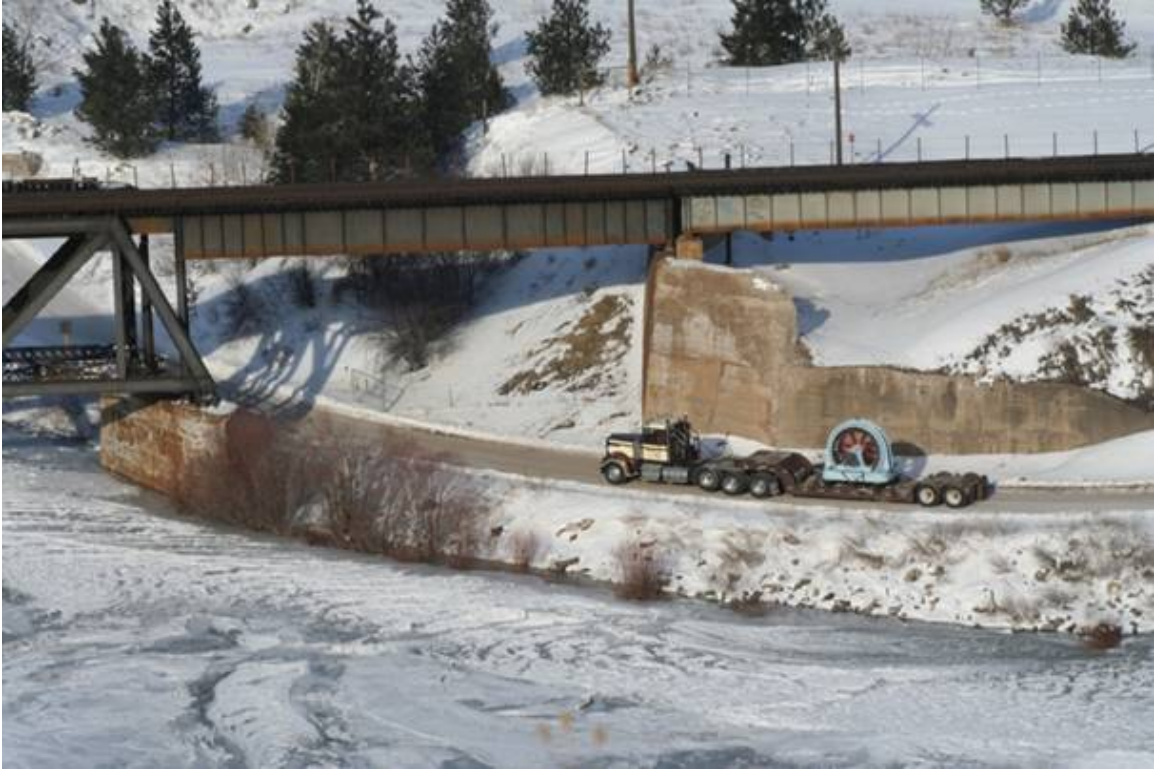
All of the generating equipment has been removed from the powerhouse. One of the functional generators was removed last week from the site on a flatbed trailer, and hauled to NorthWestern Energy's headquarters in Butte. One of the generators and other historic artifacts have been salvaged and donated to the Milltown Redevelopment Working Group, which proposes an historic interpretive center be built at or near the site in the future.
