## Milltown Dam and Superfund Site Update – April 7, 2008

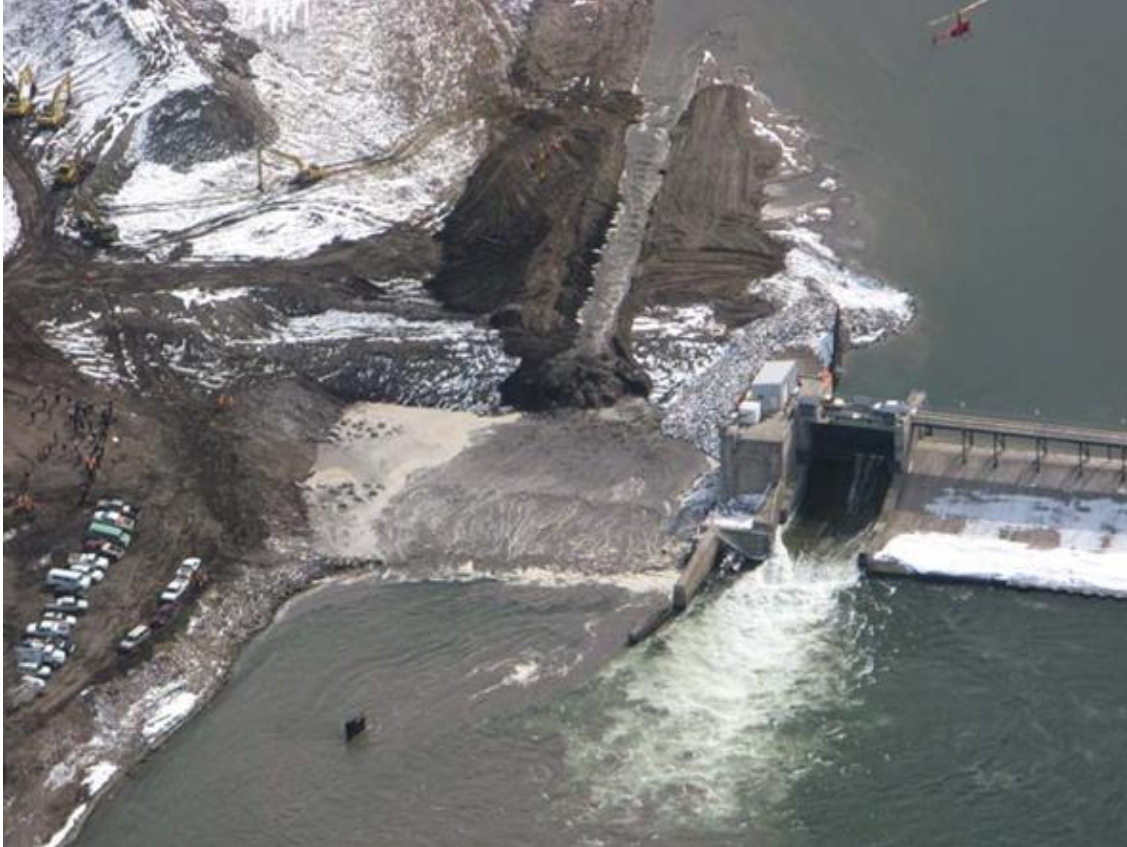
The photo above was taken by Judy and Gary Matson, West Riverside residents and members of the organization Friends of Two Rivers. It shows an aerial view looking upstream just after noon on the day of the dam breach, as water flowed into a narrow channel built to initiate the breach. Water flowed through the area previously occupied by the dam's brick powerhouse, adjacent to the dam's spillway.

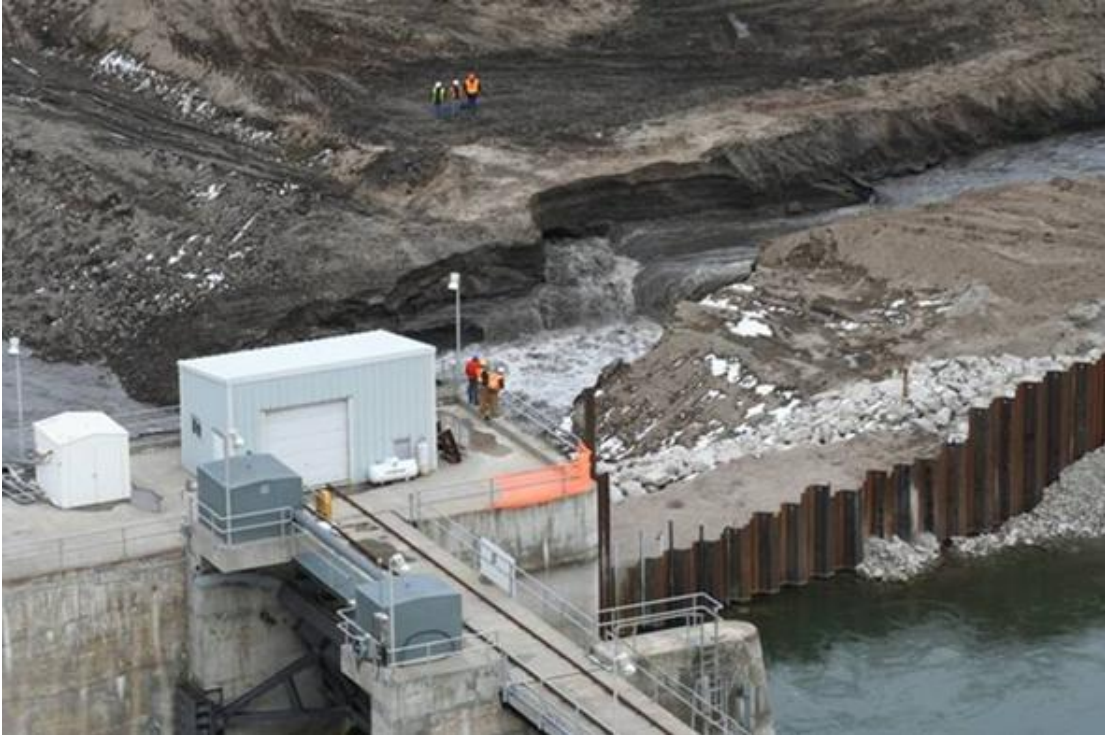
By 3:00 p.m. that afternoon, the rivers had eroded several feet down into the coffer dam and sediments in the Blackfoot River arm of the reservoir, which were not contaminated by mining waste during the 1908 flood. In the photo above, the river is flowing over and around a remnant of an old timber crib dam, probably used to divert the river when the dam was first built in 1907. The flow created a 15 foot waterfall that persisted for several hours, finally breaking through and cutting the channel upstream to the Blackfoot River at about 9:00 p.m. When that occurred, the reservoir dropped fairly quickly, raising water levels in the river downstream by one to two feet and releasing turbid water downstream.

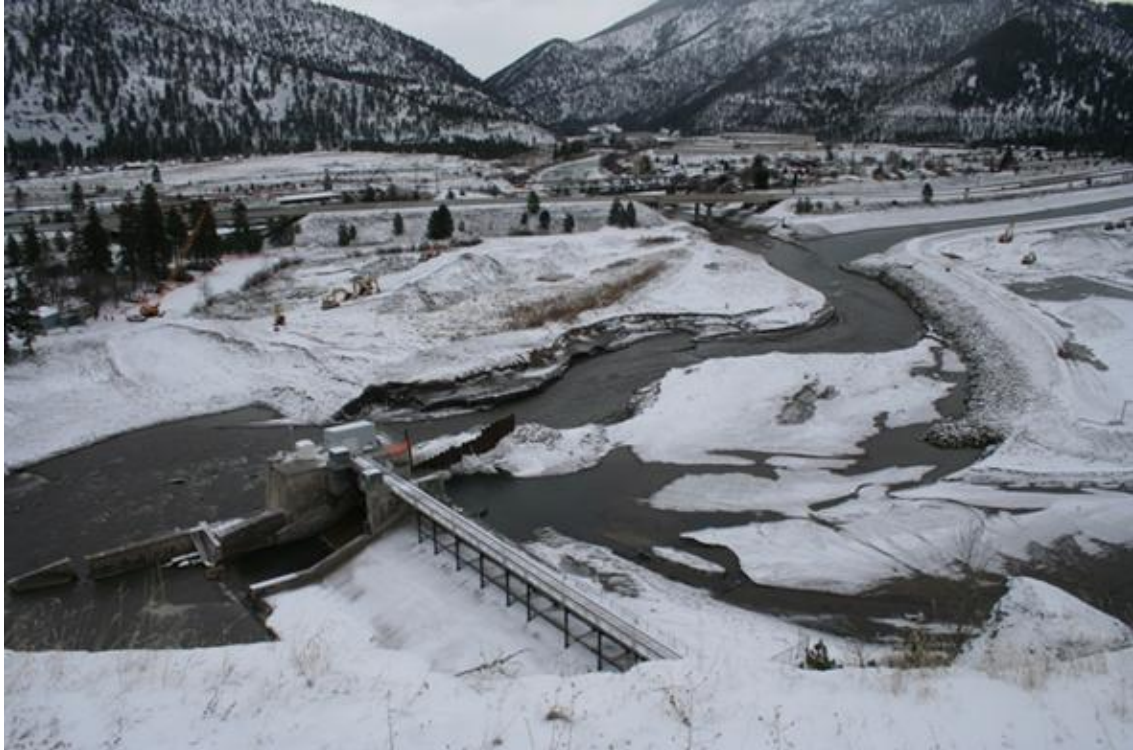
By the next morning, the rivers were re-connected, with the Clark Fork flowing out of the temporary bypass channel into the Blackfoot river, visible in the upper right hand corner of the photo above. The former Clark Fork channel of the reservoir, in the lower right hand corner, was beginning to dry out. Arsenic levels in the river downstream increased to levels exceeding the drinking water standard, as pore water drained from the reservoir sediments. But arsenic concentrations dropped off after a day or so, and did not exceed levels observed during the ice floe in 1996. No drinking water wells are known to have suffered increased concentrations of arsenic following the dam removal.

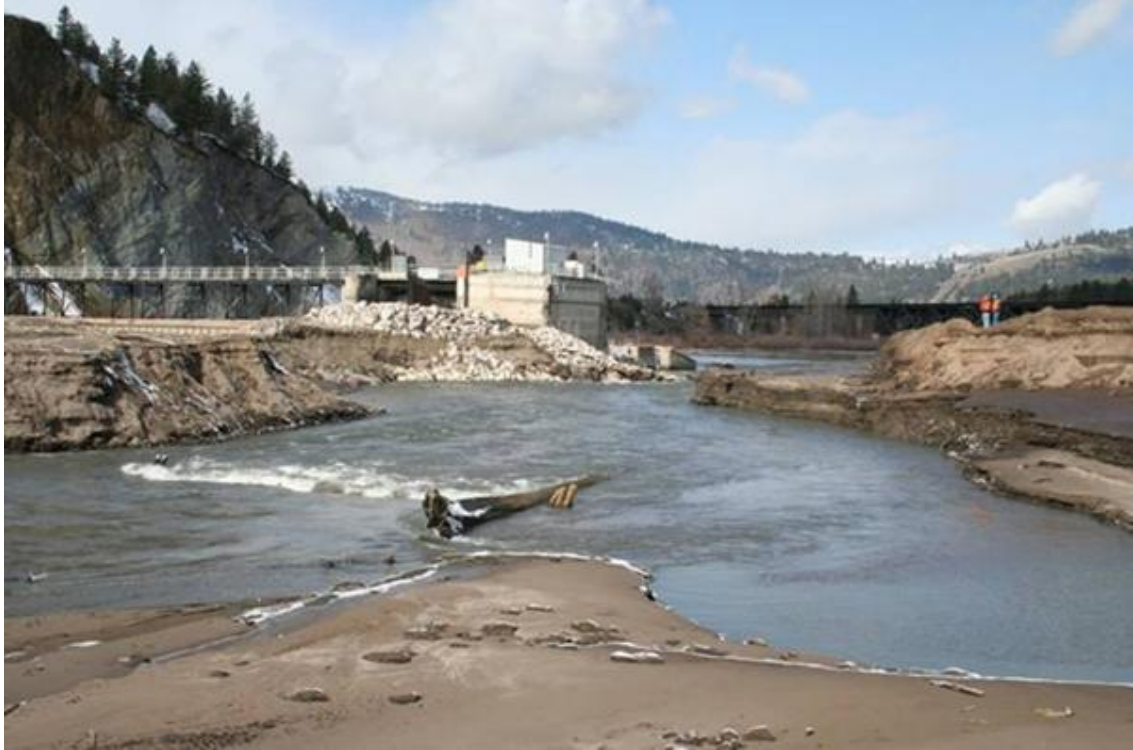
On the following Tuesday, April 1, the banks of the Blackfoot River exposed sandy material submerged in the reservoir for most of the past century. Blackfoot River sediments eroded downstream, but not at levels predicted because the river flows are very low for this time of year. For example, the Clark Fork River below the dam site is flowing today at about 1,140 cubic feet per second (cfs), and the all time record low flow for this date in 1936 was 1,080 cfs. For comparison, the flow in 1908 was estimated at about 48,000 cfs. While the river flows have been very low, concentrations of suspended sediment have been no worse than predicted in studies leading up to the dam's removal. Thankfully, there has not yet been any mortality in fish populations downstream or in fish placed in cages by biologists to study the effects of the dam's removal.

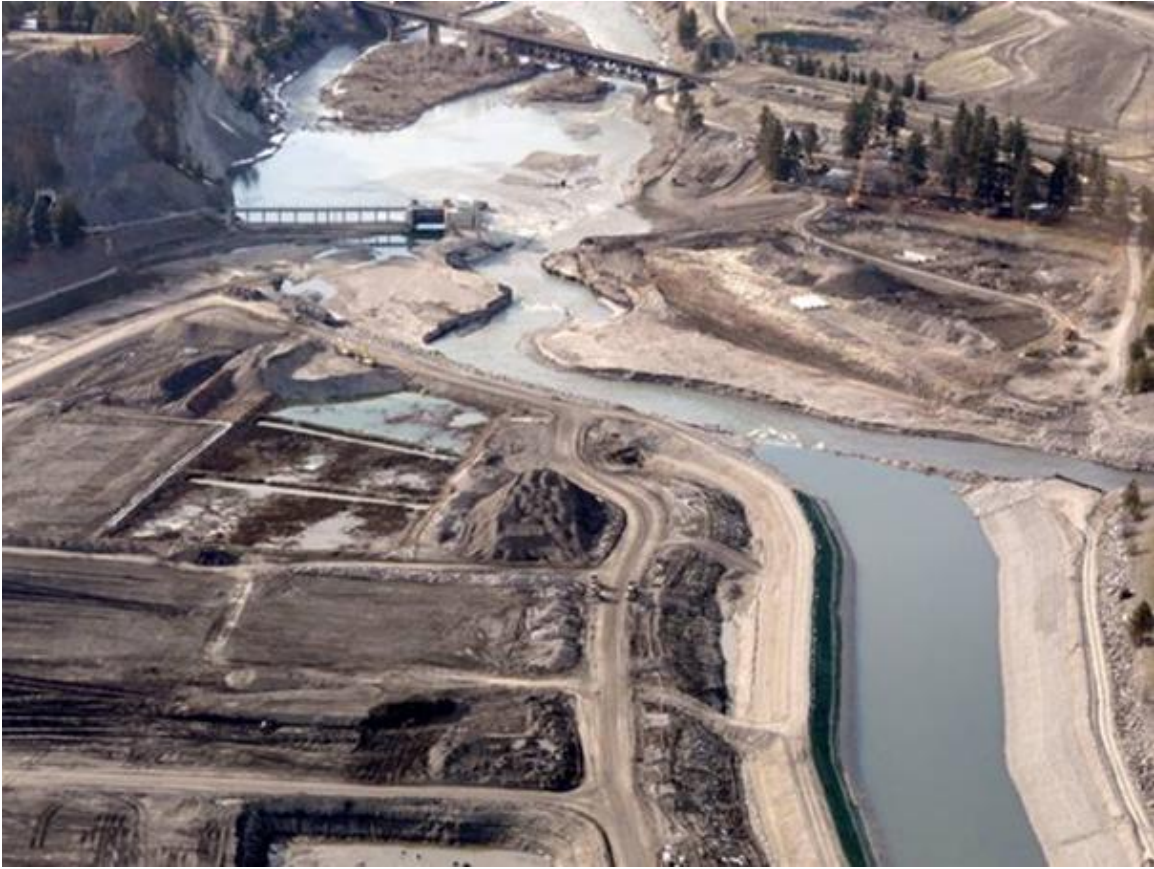
The aerial photo above was taken by Mike Kustudia, of the Clark Fork River Technical Assistance Committee (CFRTAC) about a week after the dam breach. This photo is looking downstream, with the Blackfoot River flowing in from the right and joining the Clark Fork at the bypass channel outlet before flowing through the former dam site in the upper portion of the photo. Most of the sediment along the Blackfoot River below the bypass channel was expected to erode fairly quickly during the dam breach or this spring as water flows increased in the rivers. But because the rivers are flowing at such low levels, these sediments have not eroded downstream. This has presented the opportunity to remove and protect some of these sediments from erosion before spring runoff. EPA and the State have required Arco to complete this work. The sediment bar along the right bank of the river between the bypass channel and the former dam will be removed, and the sediments just upstream of the dam's spillway will be protected by early completion of the temporary coffer dam which was to be built for the spillway removal this summer. This coffer dam may be completed this spring, assuming the rivers stay low for the next several weeks to allow the work to be done. This is especially important since the sediments upstream of the spillway contain higher levels of copper and arsenic than the sediments in the Blackfoot channel.

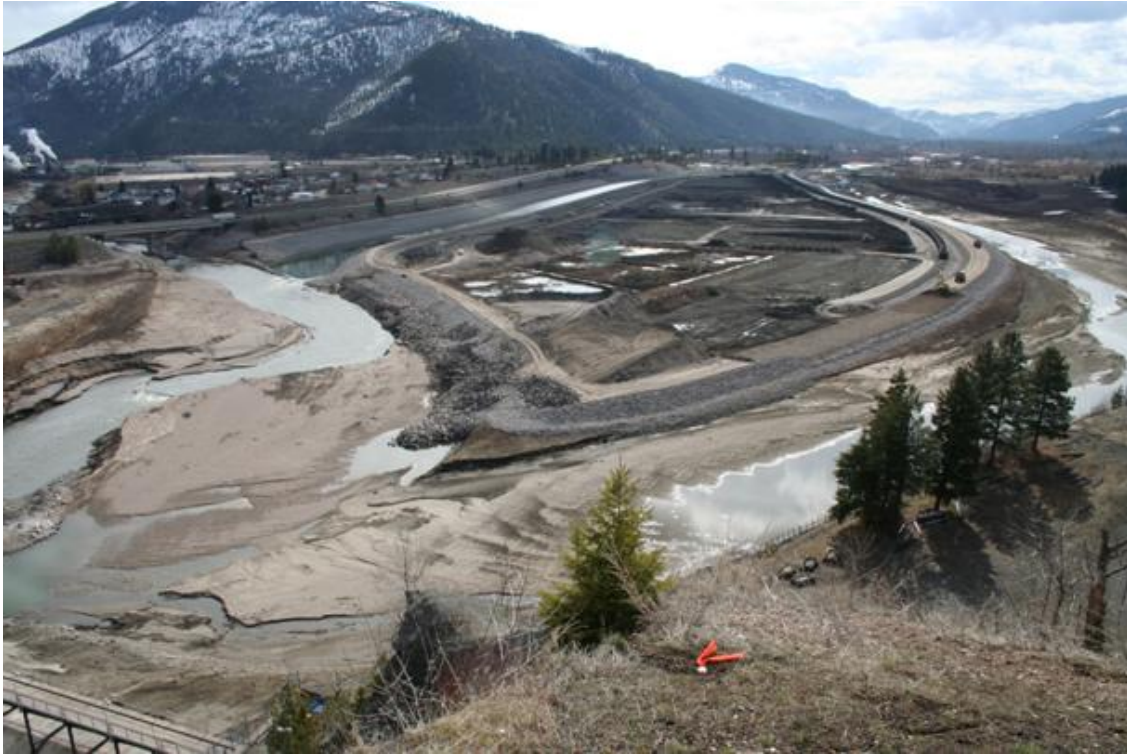
This photo taken today shows a view of the cleanup area from the bluff overlook. Exposed sediments upstream of the spillway in the former Clark Fork Channel are to be removed. The new coffer dam will be constructed from the point of the contaminated sediment area, across to the north end of the dam's spillway and radial gate.

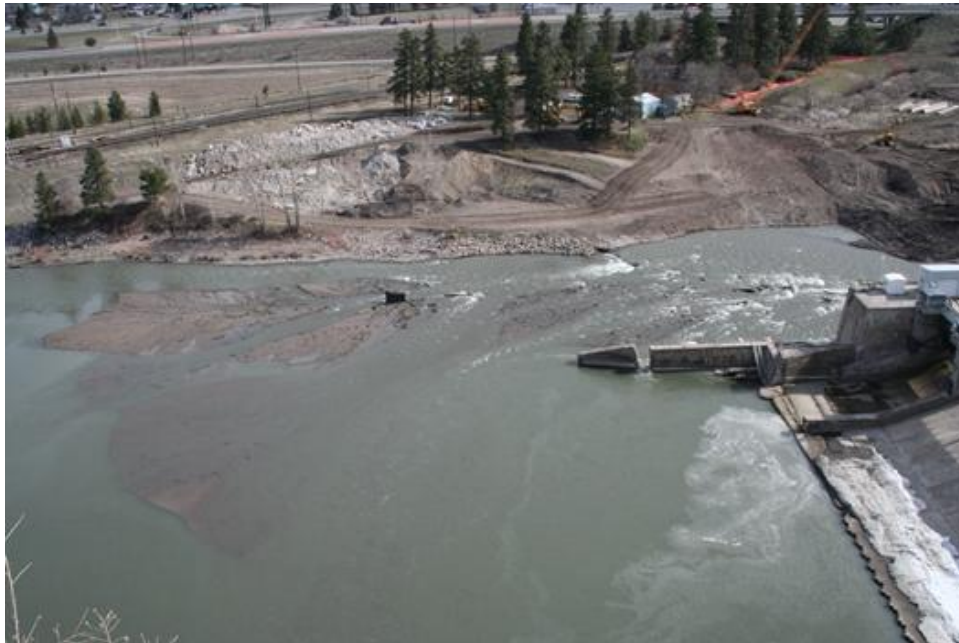
Downstream of the dam, sands and gravels are depositing and beginning to fill in the "scour hole" created by the force of the water over the dam for the past hundred years.

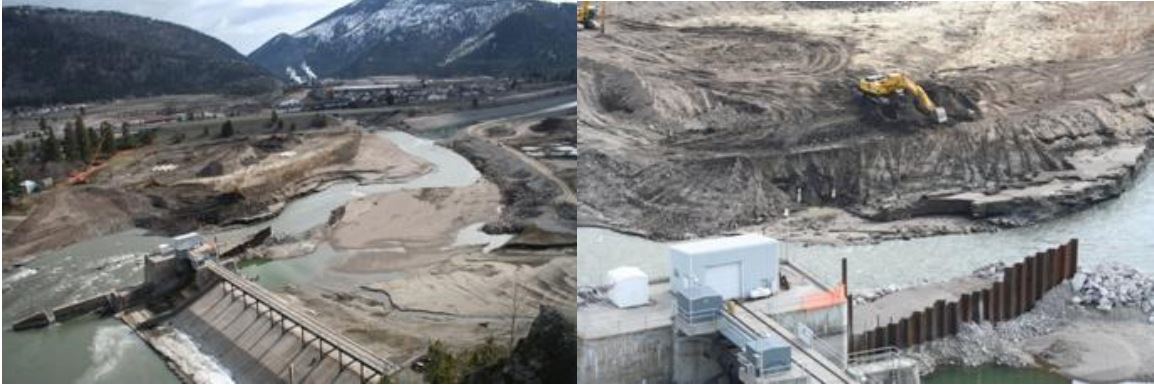
The photos above show views from bluff today. An excavator is beginning to remove sediments near the Blackfoot River, just above the spillway in the photos. The removal of the additional sediments and protection of the sediment upstream of the spillway will provide further protection for the Clark Fork River downstream. Thanks to EPA and DEQ for requiring this action, and for Arco and Envirocon for agreeing to proceed cooperatively with this work!
