Milltown Reservoir Site Update, June 18, 2007.

It's been a full year since the Milltown Reservoir cleanup and dam removal project began with the reservoir drawdown in June, 2006. The project remains on schedule for dam removal in March 2008. The reservoir is drawn down about 7.75 feet today, down from a maximum drawdown of 12 feet earlier this year.

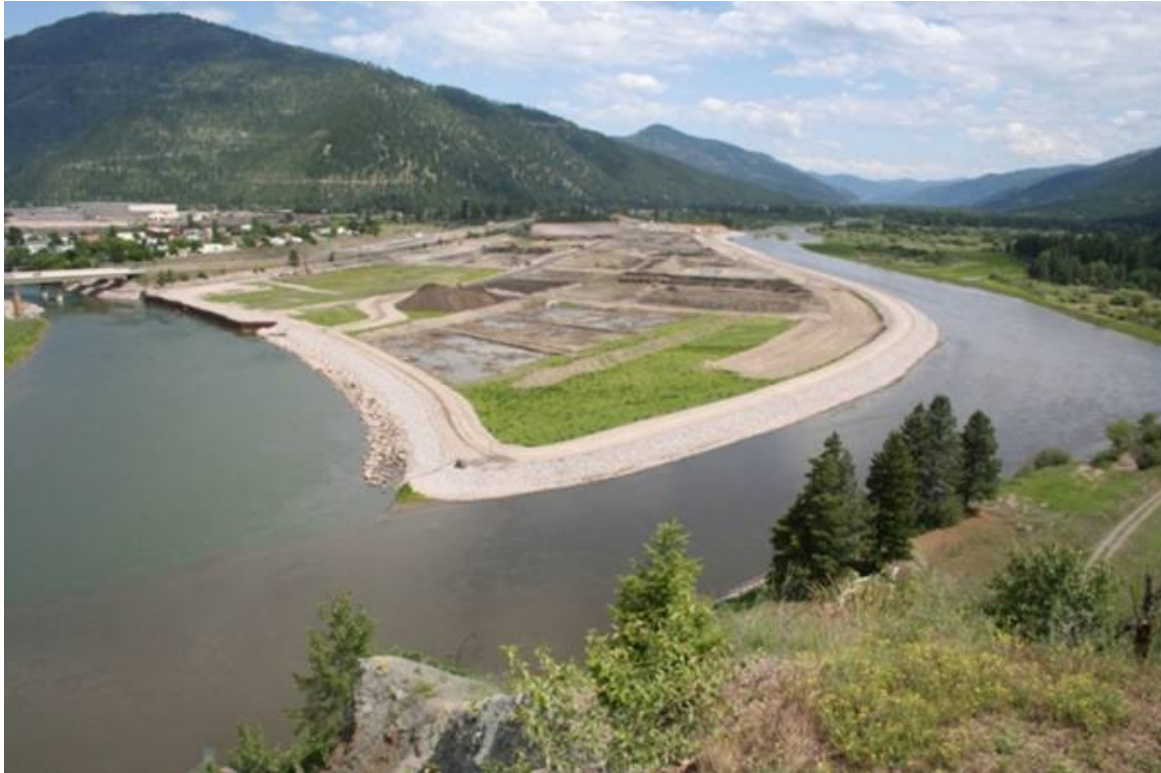
This overview photo shows the significant progress made at the site in the past month. The flood berms surrounding the contaminated sediment area are complete, and work has begun in earnest on excavation of the bypass channel. Later this summer a rail spur will be constructed alongside the Clark Fork flood berm, and stockpiled sediment removed during excavation of the bypass channel; will be shipped off site in September. Note the visibly increased sediment load in the Clark Fork channel on the right, which is due in part to elevated sediment levels coming into the reservoir from the Clark Fork upstream and also from sediment scouring from the drawn down reservoir. The flow in the river today is about 5,260 cubic feet per second (cfs). Peak flows of about 9,000 cfs occurred in May and again in June this year. A ten year flood event for the combined flows of both rivers is 25,900 cfs. The flood berms surrounding the contaminated sediment were designed to handle at least a ten year flood event.

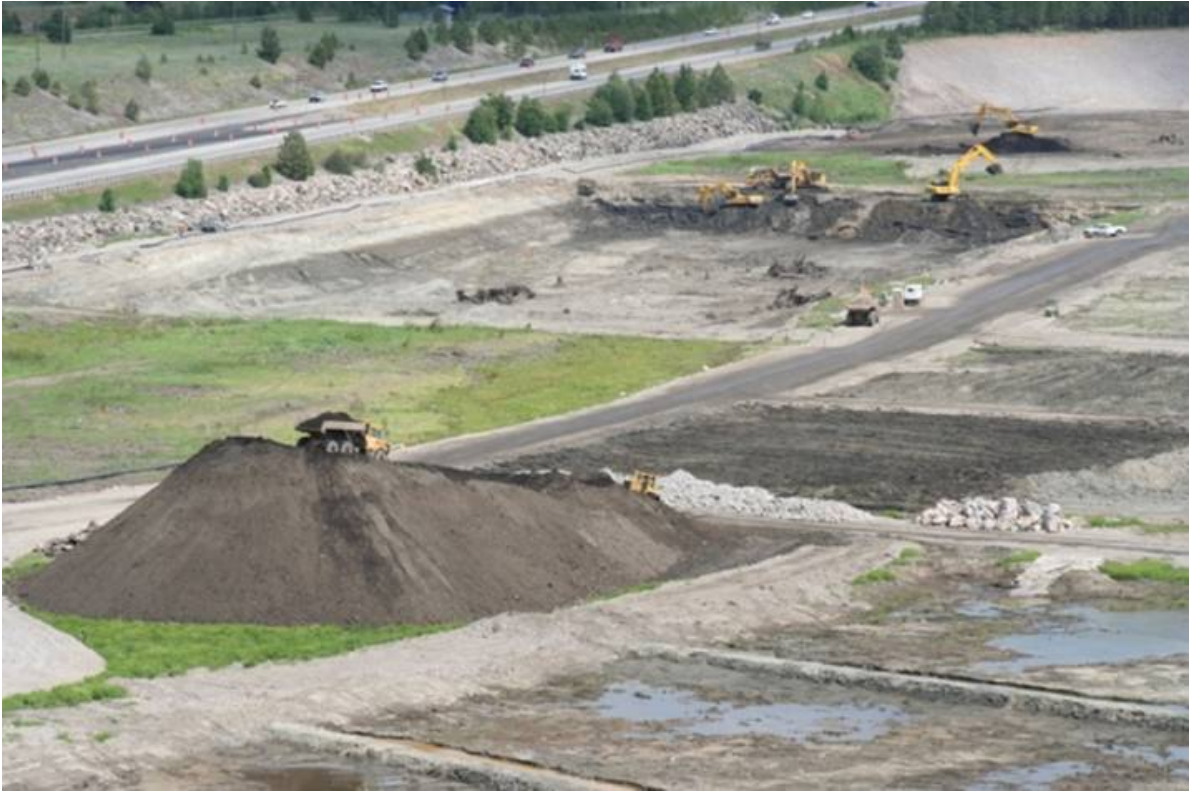
The photo above shows excavation of the bypass channel near the toe of the Interstate highway. The channel will be 100 feet wide at the bottom, and sized to handle the 100-year flood after the dam is removed next spring. A large truck is stockpiling clean fill in the foreground. This is soil that was removed from an old dump area near the interstate, following removal of solid waste including tires and steel. This material will be stored on site until after the river is diverted into the bypass channel and the Milltown Dam is removed in 2008. It will eventually be disposed of in the low are near tunnel pond on the south side of the reservoir.

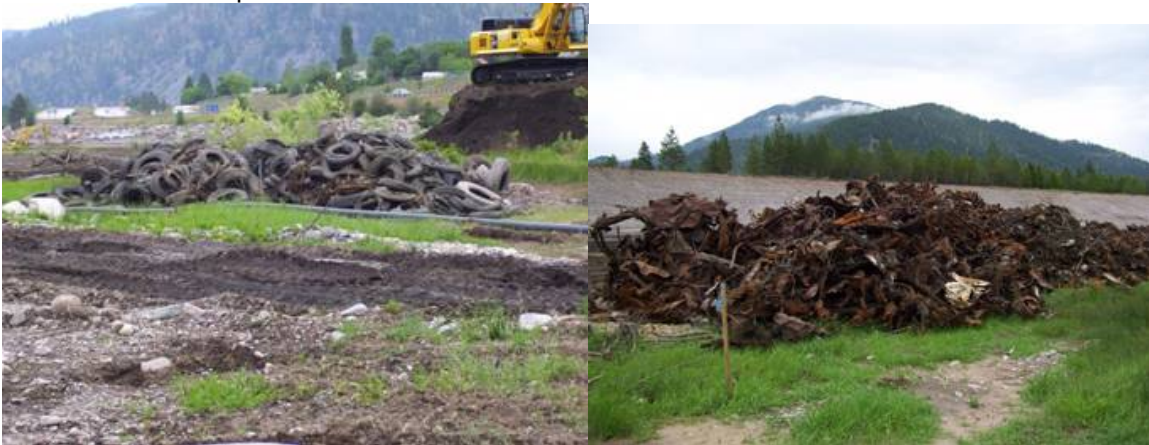
These photos show the tires and steel removed from the old dump area near the Interstate. These materials will be disposed of at the Missoula landfill, or recycled.

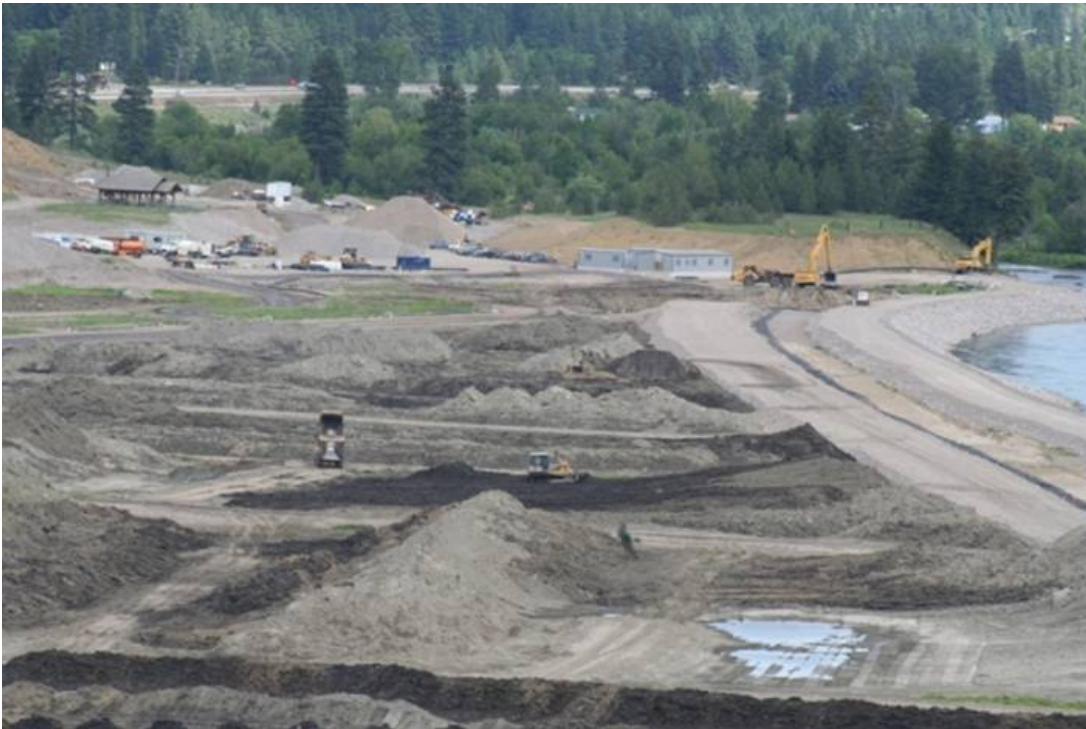
The photo above shows the upstream end of the project area, including contaminated sediment stockpiles in the foreground and the Envirocon construction offices in the background. Excavators are beginning to dig the upstream end of the bypass channel in the upper right hand of the photo. Envirocon has installed additional wells to remove water from the sediments to enable excavation. Water is now being pumped directly to the Clark Fork River at the upper end of the bypass channel, as well as the to the Blackfoot River at the downstream end of the channel, which was initiated last fall. The rate of pumping has increased from about 400 gallons per minute to about 3,000 gallons per minute. However, the quality of the water in the upper end of the excavation is much better, with lower arsenic and iron concentrations. Total loading of contaminants to the river has remained fairly stable, even with the recent increased rate of pumping.
