Milltown Reservoir Site Update, July 9, 2007

Construction work at the Milltown site is now focused on three activities, 1) excavation and construction of a bypass channel for the Clark Fork River, 2) construction of a rail spur for transport of contaminated sediments, and 3) stabilization of the Interstate Highway bridges over the Blackfoot River.

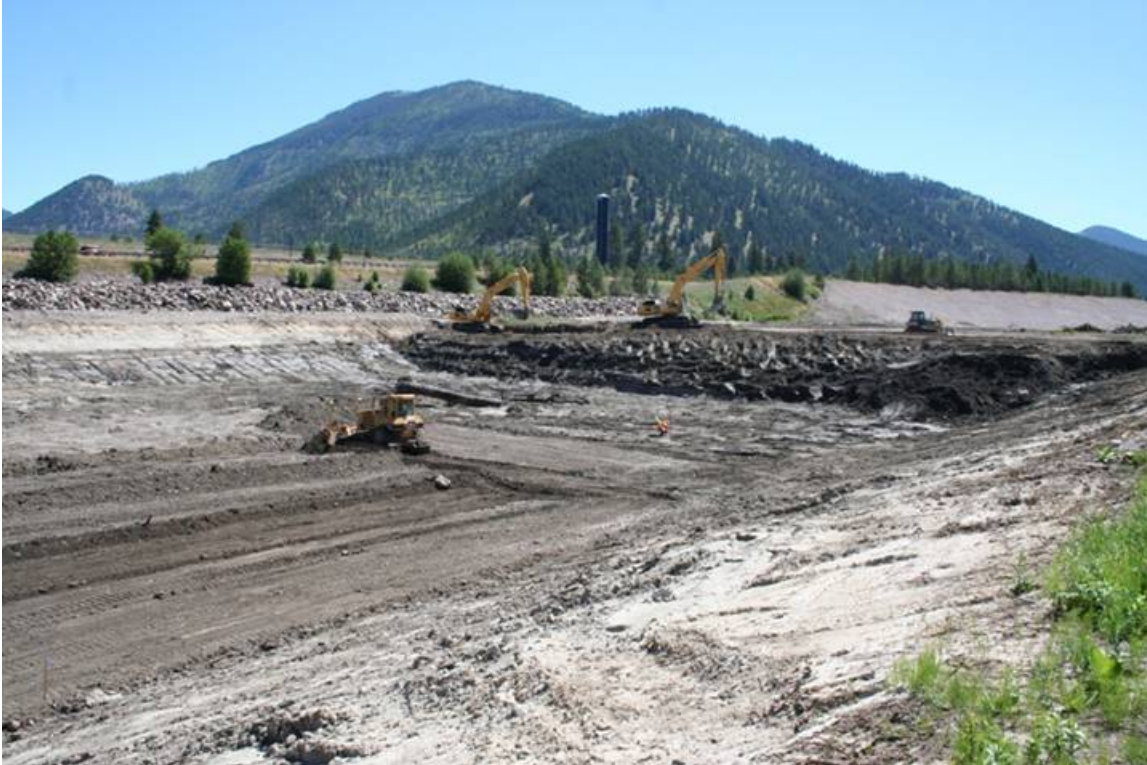
The photo above shows the bypass channel excavation near the Interstate Highway. The excavation is progressing upstream of the test pit dug last fall. The channel is now about 33% complete, with more than 200,000 cubic yards of contaminated sediment removed and stockpiled on site. Once complete, the Clark Fork River will be diverted into the bypass channel, possibly in October. The channel will be 100 feet wide at its base, and sized to handle the 100 year flood by next spring when the dam's spillway is removed. The river will remain in the bypass channel for at least two years while the remainder of the most contaminated reservoir sediments are removed and shipped to the Atlantic Richfield Waste Repository near the former Anaconda Smelter. The excavation shown in the photo is much wider than 100 feet, because a flood control berm must be installed in the foreground of the photo to protect the contaminated sediments from erosion.

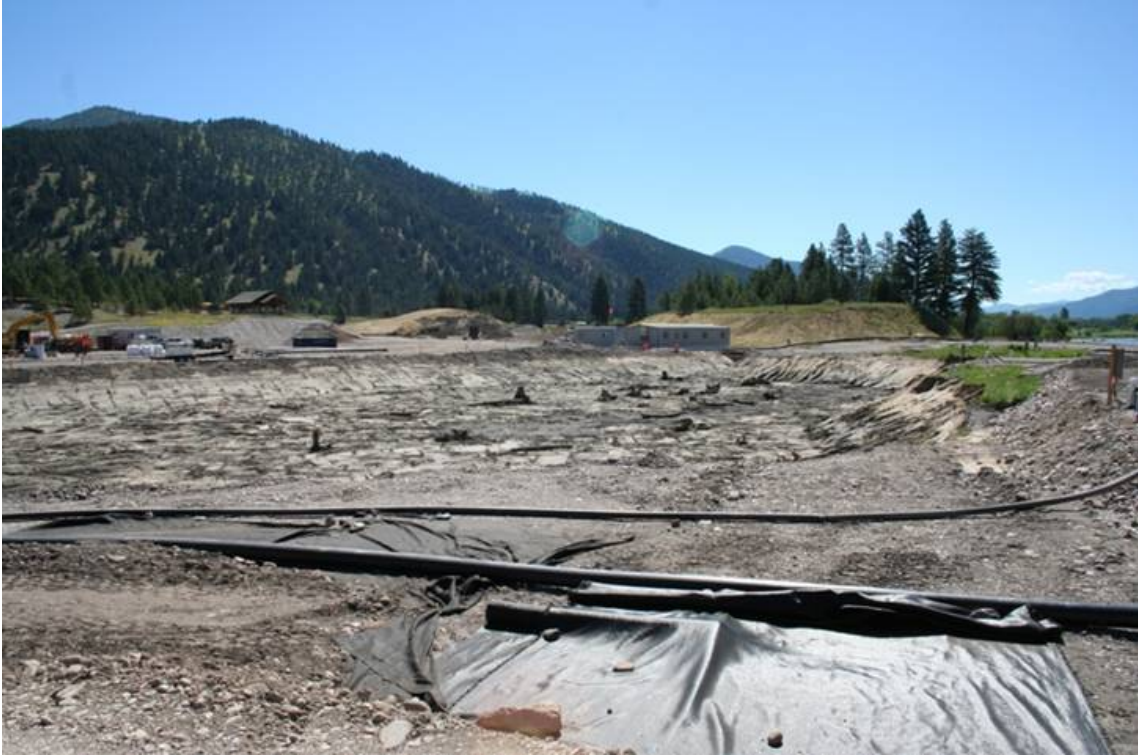
The photo above shows another section of bypass channel excavation at the upper end of the reservoir. This is the area where the rail spur bridge will be constructed over the bypass channel. In the foreground is a synthetic fabric liner placed under the rail bed. The rail line will enter the site from the direction of the construction trailer and pavilion in the background. At the base of the excavation many ponderosa pine stumps are visible. These trees were cut in 1906-7 prior to the construction of the dam by William Andrews Clark. The pipes going across the photo are for discharge of water from wells installed to lower the water table in the area of the excavation.

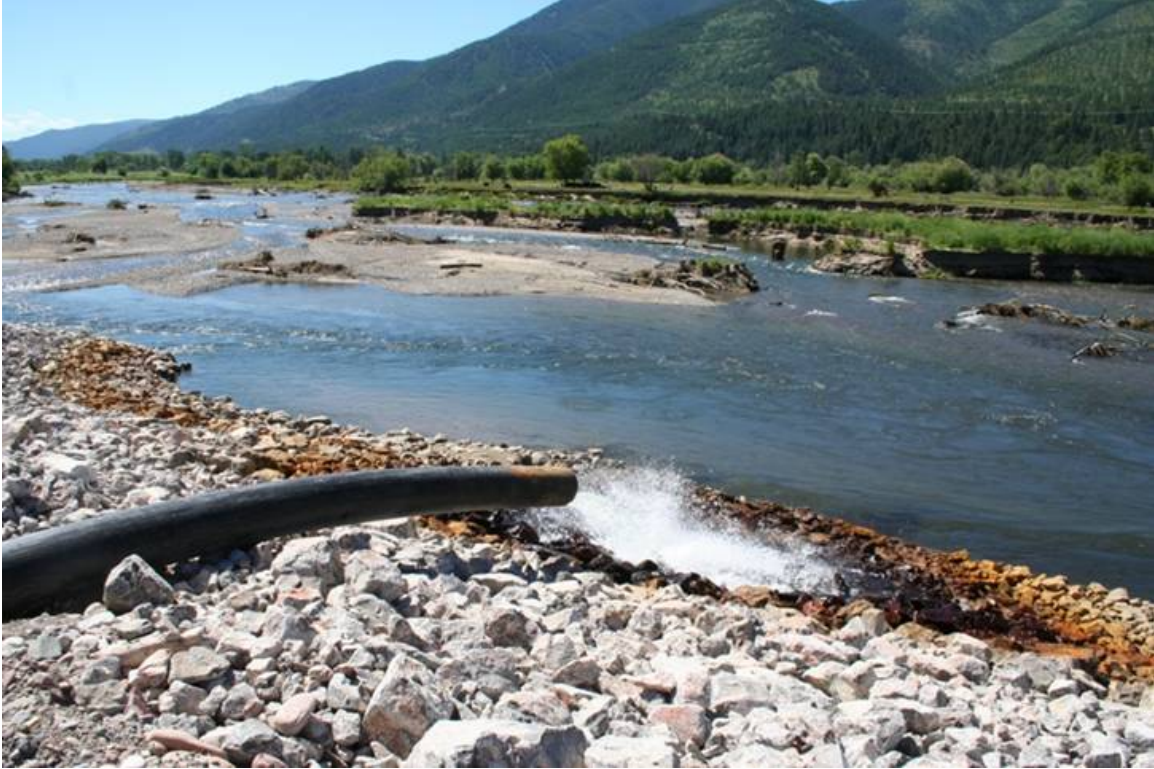
The photo above shows the location of one of the dewatering discharge points to the river. The discharge water is high in iron, causing the rusty stain on the rocks next to the river. Envirocon has installed a series of wells to lower the water level in the excavation area, and is now pumping about 3,500 gallons per minute to several discharge points along the Blackfoot and Clark Fork channels. This is up from about 400 gallons per minute during last fall's bypass channel construction test. While the volume of water pumped has increased, the concentration of contaminants has decreased. Most of the water now being pumped to the river is coming from the upper reservoir area, and arsenic concentrations are much lower there. The average concentration of arsenic in the discharge water is now about 100 parts per billion, while the concentration discharged last fall ranged from about 700 to 900 parts per billion. Although high in arsenic, the volume of the discharge is very low compared to the flow of the rivers, and the discharge has not yet been detectable at the monitoring station 1.6 miles downstream of the dam.

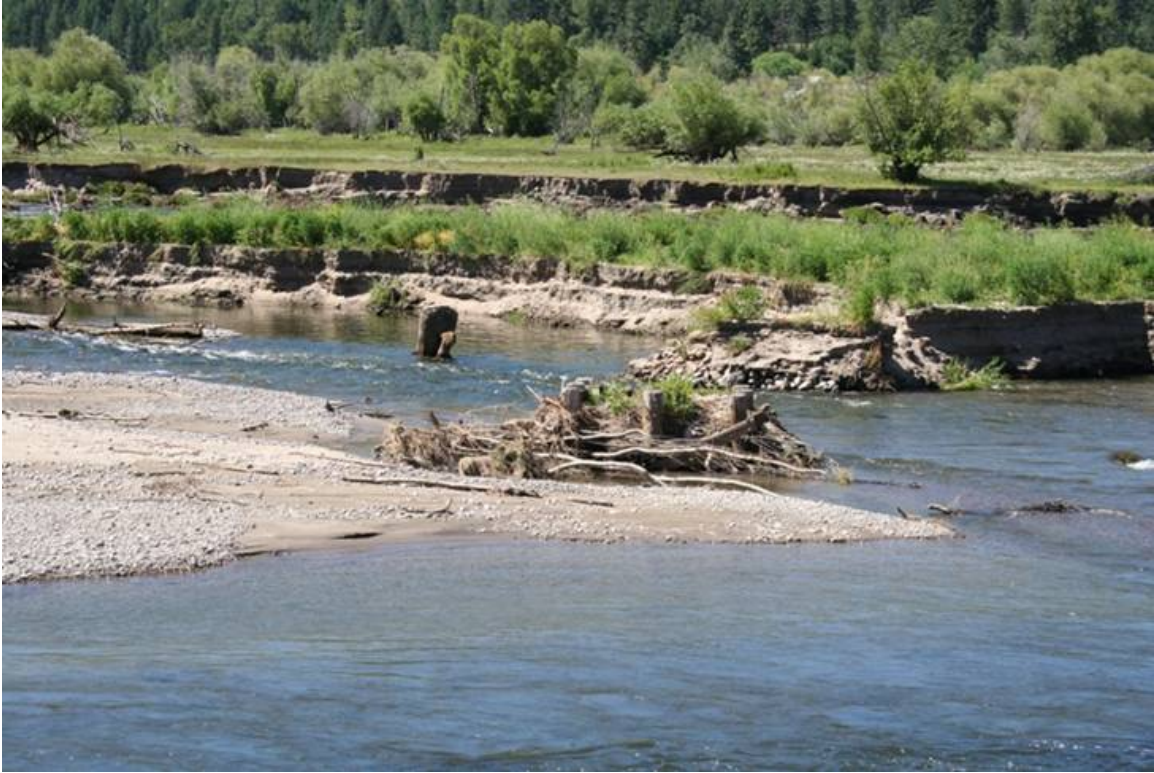
The photo above shows the Clark Fork channel just upstream of the former Milwaukee Railroad bridge, known locally as the Duck Bridge, about one mile upstream of the dam. The remnants of an old wagon road bridge are visible, and erosion of the far river bank has exposed a portion of the rock foundation for the bridge. The island has eroded significantly this spring and early summer. The sediments in the island appear to be primarily sandy material. Several people have reported sandy deposits in the river banks and eddies downstream of the dam into Missoula this summer. This may be one of the main sources of that sandy material, along with sediments eroded from the Blackfoot River where the Bonner Dam was removed in late 2005.

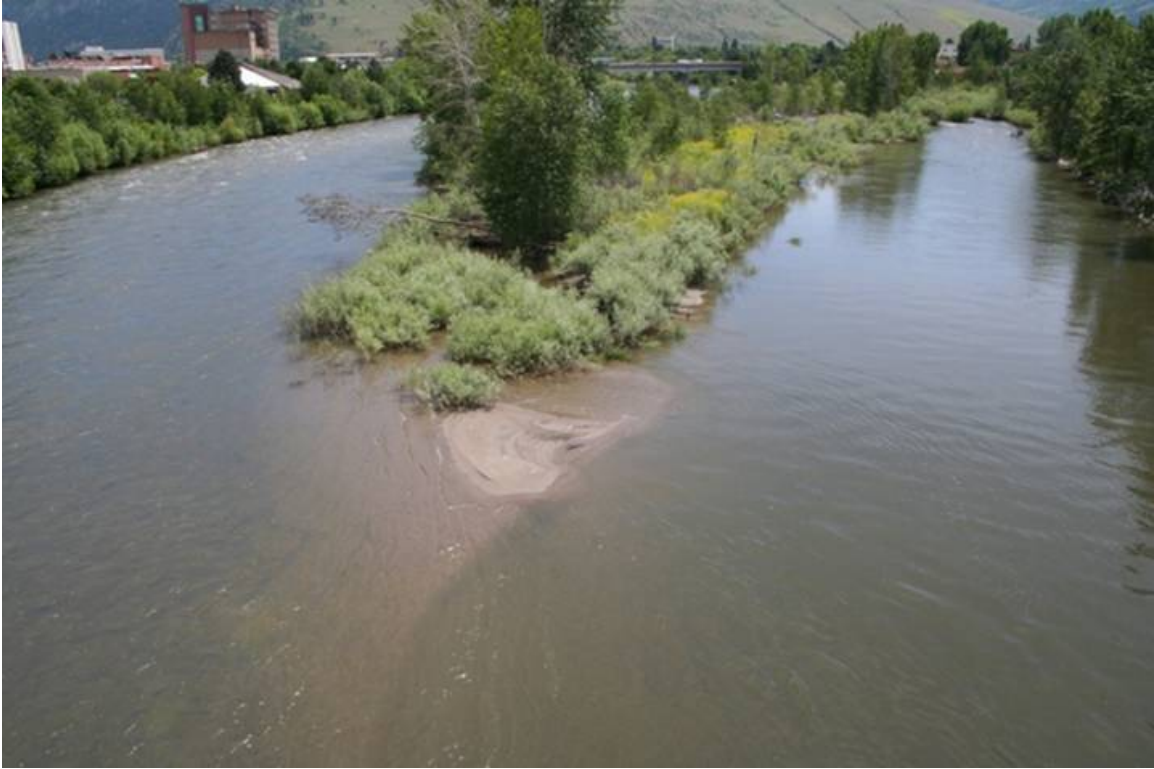
The photo above shows one of the sandy deposits, just upstream of the Orange Street Bridge in Missoula. This type of deposition was predicted by computer models before the project began, and there has actually been less sediment release so far than predicted. These sandy sediments likely originated from the Blackfoot River or the Clark Fork upstream of former Milwaukee Railroad Bridge. Sediments originating from the Blackfoot River are not contaminated with mine waste. Sandy sediments from the upper Clark Fork arm of the reservoir are the cleanest of the Clark Fork sediments. This is because there is less surface area on each particle of sediment for the arsenic to adhere to, compared to smaller sized particles such as silts and clay. The monitoring program for the Milltown project includes some sampling of the river bed sediments and aquatic insects for metals and arsenic, and aquatic insect populations will also be checked in August. Depending on springtime river flows, it may take several years for this sediment to move downstream. After the 1996 ice event, sediment accumulated in the river downstream but high river flows in 1996 and 1997 moved it downstream. This year's spring runoff was not high enough to carry much of this bedload downstream.

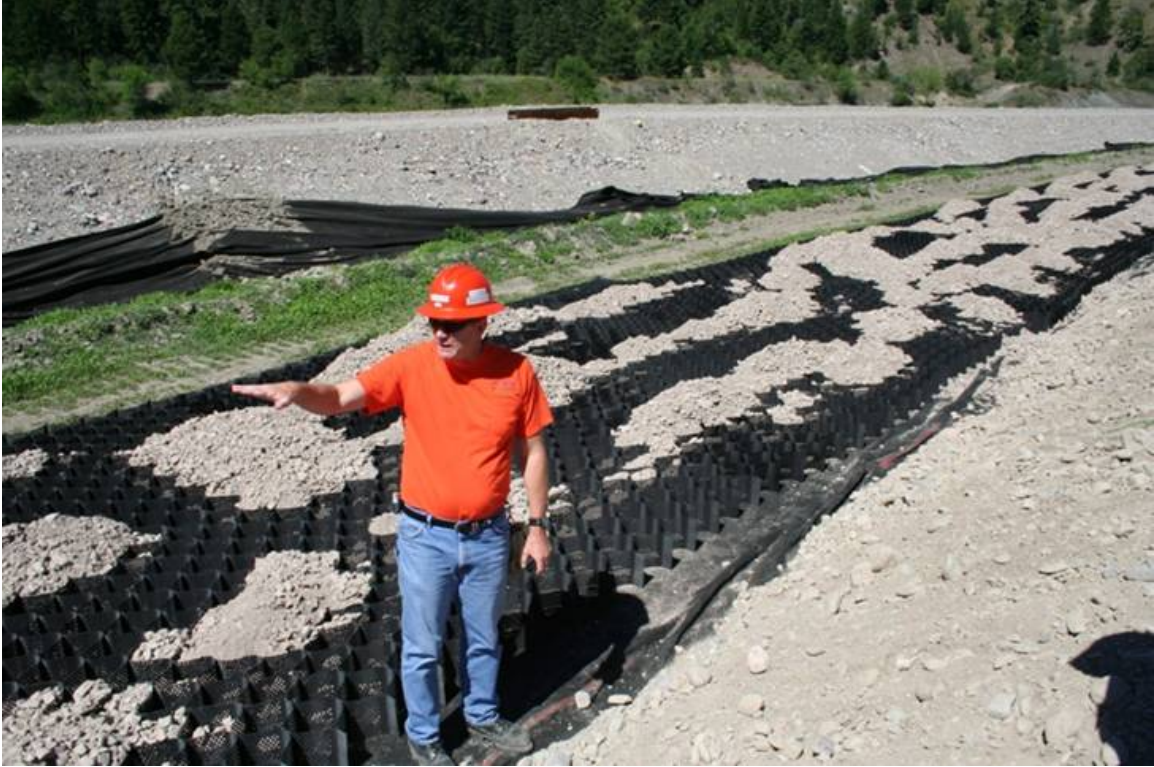
In the photo above Matt Fein from Envirocon describes the construction of the rail spur on the reservoir sediments. Because the sediments are soft, and uneven settlement may occur in the rail line, Envirocon has installed a plastic geo-grid filled with rock to support the rail bed. This work is now complete, and Envirocon will now place gravel sub-grade over the grid. Later this summer Montana Rail Link will install the ballast, railroad ties and track. Sediments will begin to be shipped off-site in September.

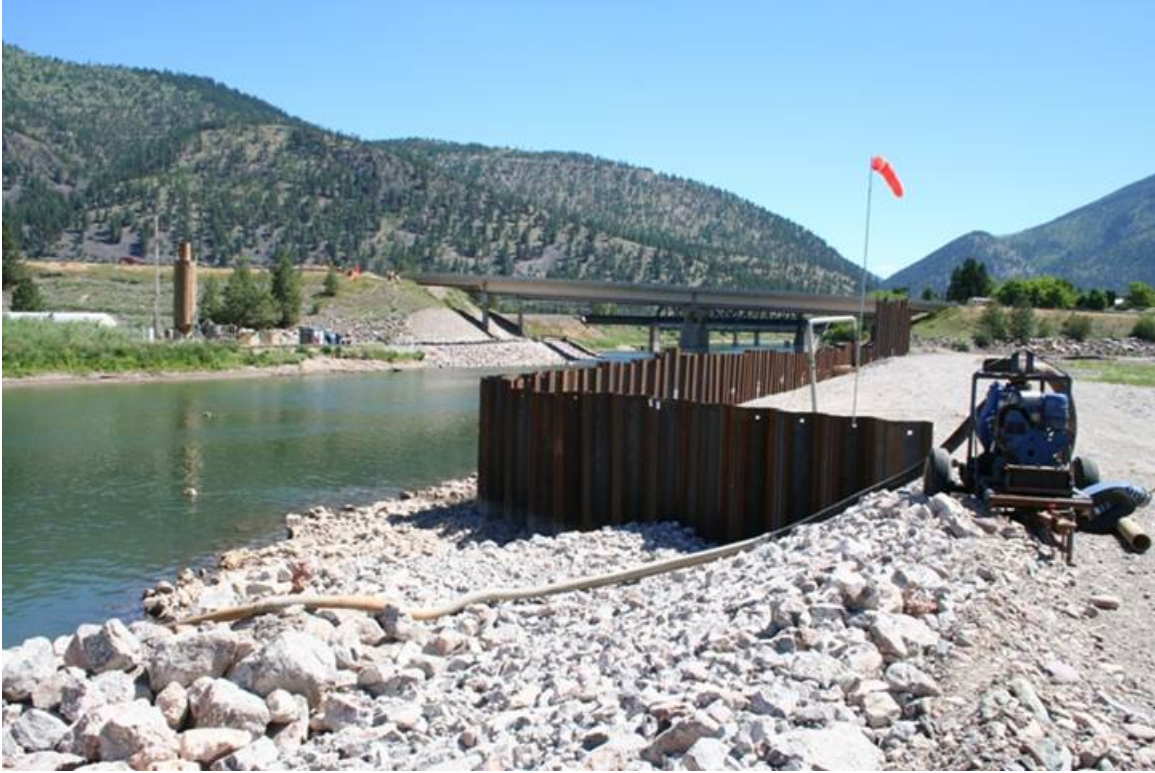
This photo shows the metal sheet piling at the end of the bypass channel where it will flow into the Blackfoot River. In the foreground is a pump and line to the river where water is withdrawn for loading water trucks to control road dust on site. Envirocon now has two water trucks working full time to control dust on site. In the background, the eastbound lane of I-90 is visible. EPA is paying for stabilization or replacement of the highway bridges over the Blackfoot River. The work is supervised by the U.S. Army Corps of Engineers. Spaulding Construction and other contractors are currently working on stabilization of the east bound lane. This involves the injection of concrete grout into interlocking columns to fortify the embankments, and driving steel "H-piles" into the ground to support the abutments of the bridge. Later this summer the center piers will be fortified and deepened to withstand the forces of the river following dam removal. The I-90 bridge work is scheduled for completion this fall.

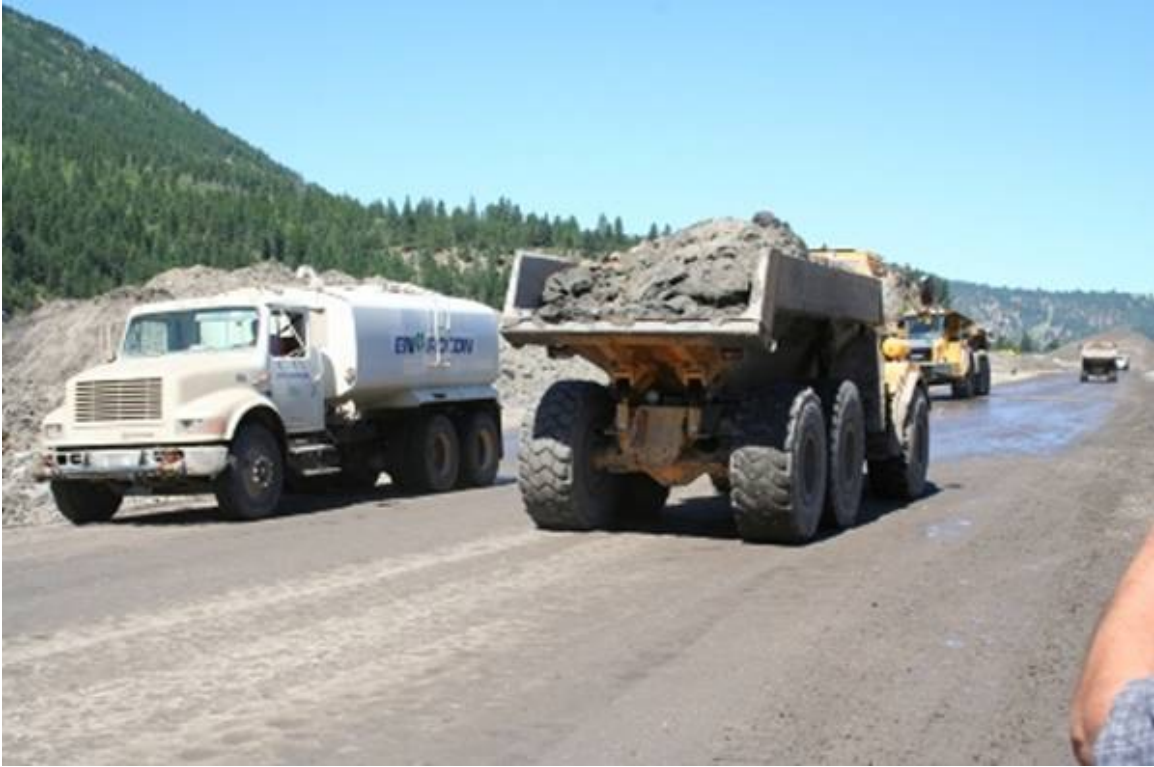
This photo shows construction traffic at the reservoir site, with trucks hauling contaminated sediments to a stockpile and a water truck controlling dust on the road. Envirocon is performing the work for Atlantic Richfield Company, and now has more than 30 full-time employees working on site.

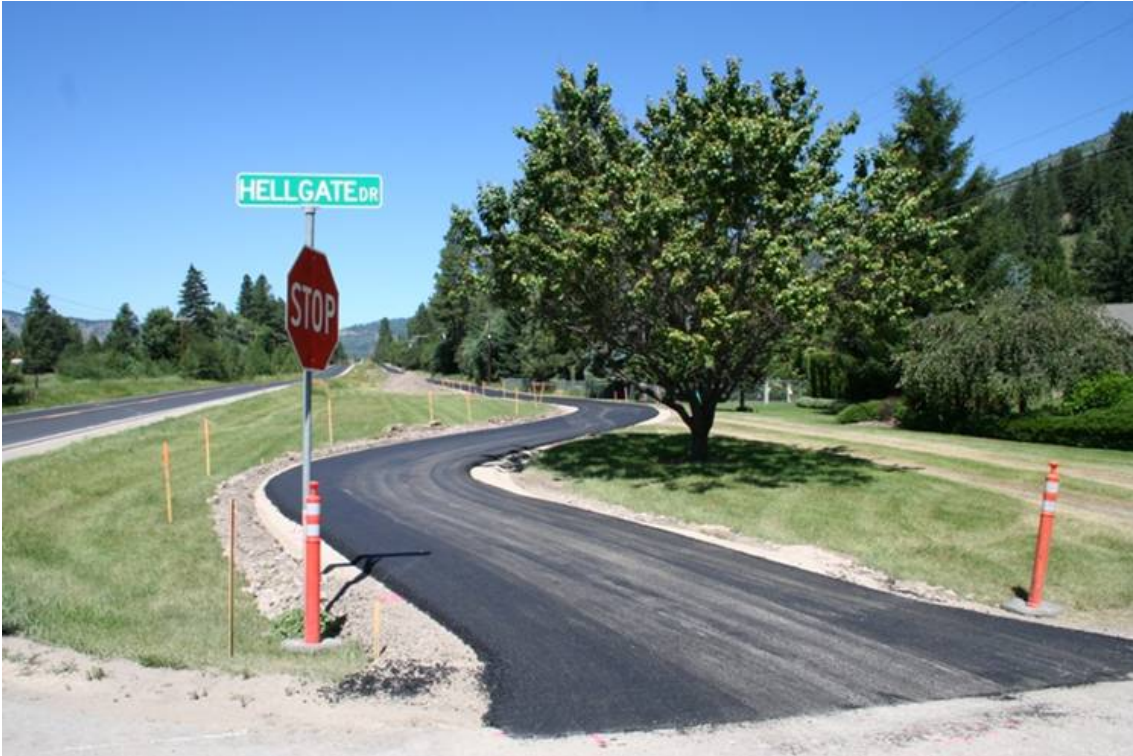
This photo shows construction of a new pedestrian trail in the Piltzville area, near the upper end of the reservoir. EPA provided Missoula County \$500,000 to complete this project, which will provide a safer route for pedestrian traffic from Piltzville to Bonner. This section of trail will be complete by some time in August, and will remain as a long-term asset for the community after the cleanup and restoration are complete. .
