Milltown Reservoir Project Update – August 10, 2007

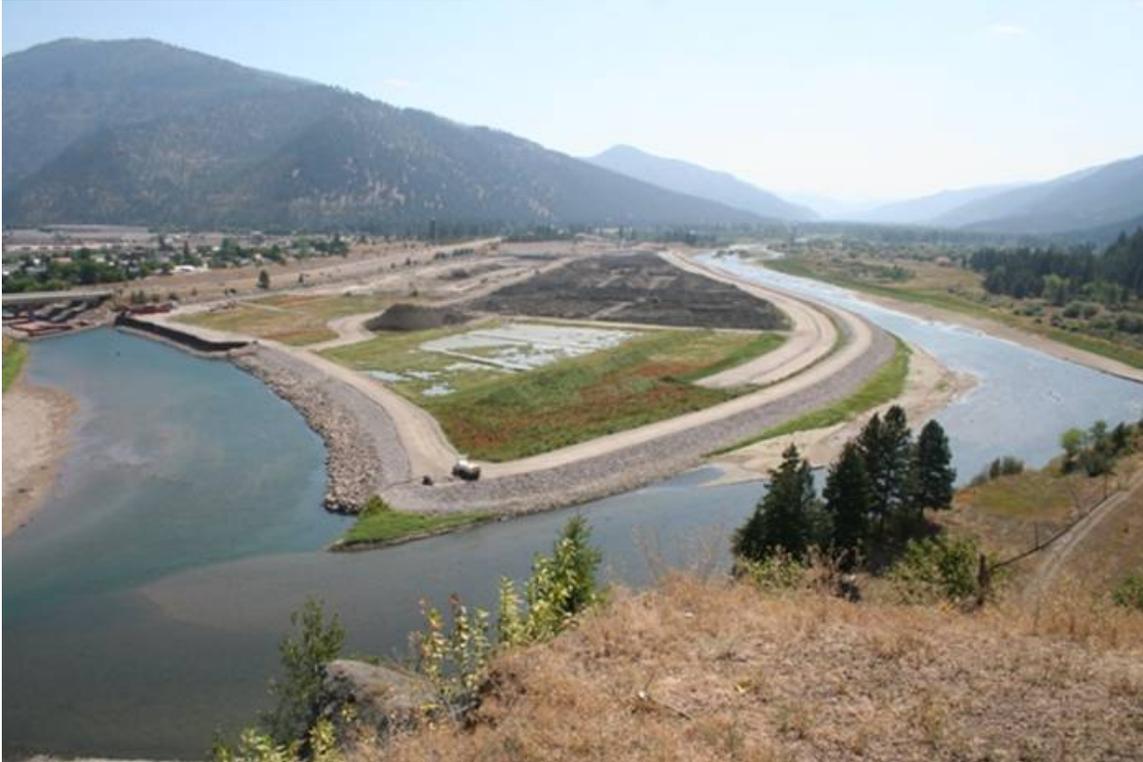
The photo above shows an overview of the site from the bluff above the dam, and was taken on a site visit this week with Plum Creek staff. Plum Creek is considering a donation of land to access the bluff, so that a parking area, trail and overlook can be constructed by the EPA. The Carpenters' Union has stepped forward and agreed to accept the land until such time as the State of Montana decides whether to accept it and other lands in the reservoir area for use as a State park/recreation area and fish and wildlife reserve. Thanks to Dennis Daneke of the Union for his hard work, and to retiring County Commissioner Barbara Evans for her tenacity in moving this project forward. We hope to hear from Plum Creek on the land donation in the next several weeks, so stay tuned. For the time being, Plum Creek has posted the land no trespassing, and

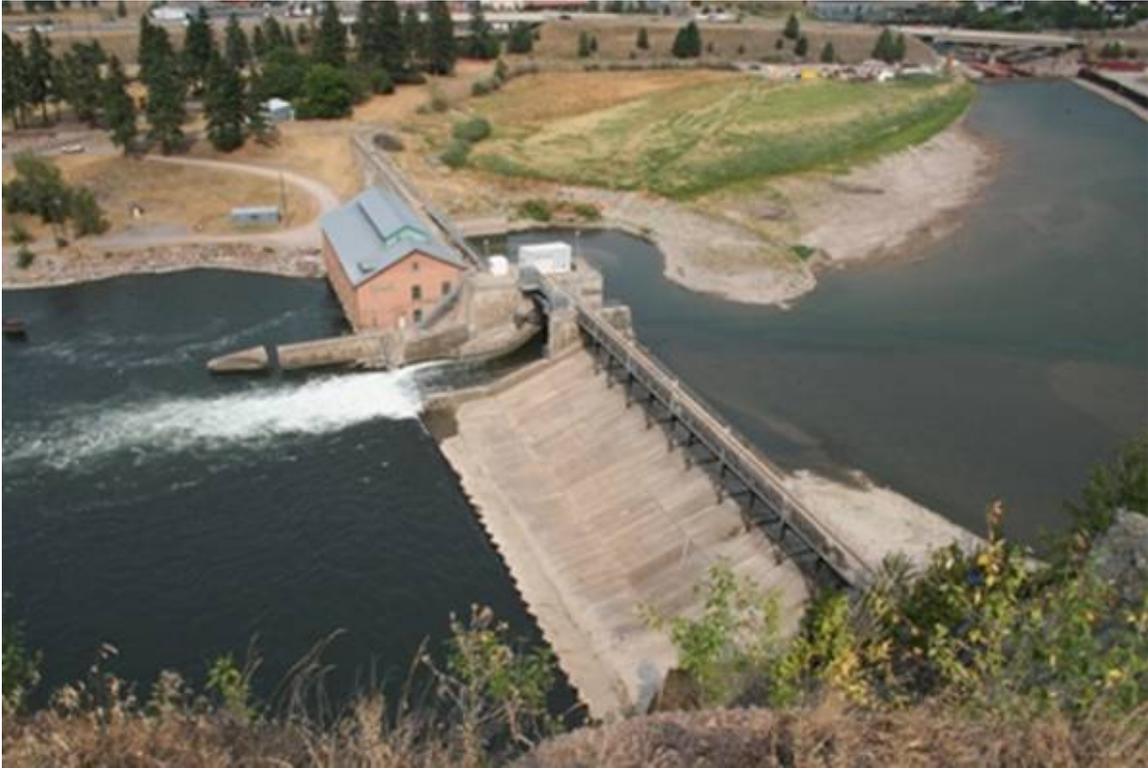
This photo shows the dam from the bluff overlook. The reservoir is currently drawn down 12 feet from full pool. All water flow is now routed through the radial gate, between the powerhouse and the spillway. Envirocon has proposed a change in plans for dam removal. Under the new plan, which is currently under review by EPA, DEQ and the Design Review Team, the powerhouse would be removed first, rather than removing the spillway first as originally planned. Plans have changed because of problems fitting the temporary gravel "coffer" dams above and below the spillway in order to remove it. During design of the coffer dams, it became clear that the gravel dams would be too large to allow excavation down below the restored river channel under the spillway. So, Envirocon has proposed to install a coffer dam upstream of the powerhouse instead, and remove the powerhouse beginning this fall. After the powerhouse is removed, the river would be diverted through the opening created by its removal, and the reservoir would be lowered to about 19 -20 feet below full pool. The Clark Fork River upstream would be placed in the bypass channel, which is more than halfway excavated now and scheduled for completion this fall. A remnant of an old coffer dam is visible just upstream of the powerhouse, extending in an arc from the shore out into the reservoir. This old gravel coffer dam would be used and extended to the radial gate, allowing water to continue to flow through the radial gate while drying up the area where the power house would be removed.

As a result of the proposal to remove the powerhouse first, plans are being made to salvage historical artifacts from the facility which can be made part of an interpretive center proposed for construction near the current dam site. The Milltown Redevelopment Working Group's History and Culture committee and the Missoula Historic Preservation Officer are coordinating plans for salvage, and will propose a list of salvage items to NorthWestern and Envirocon.

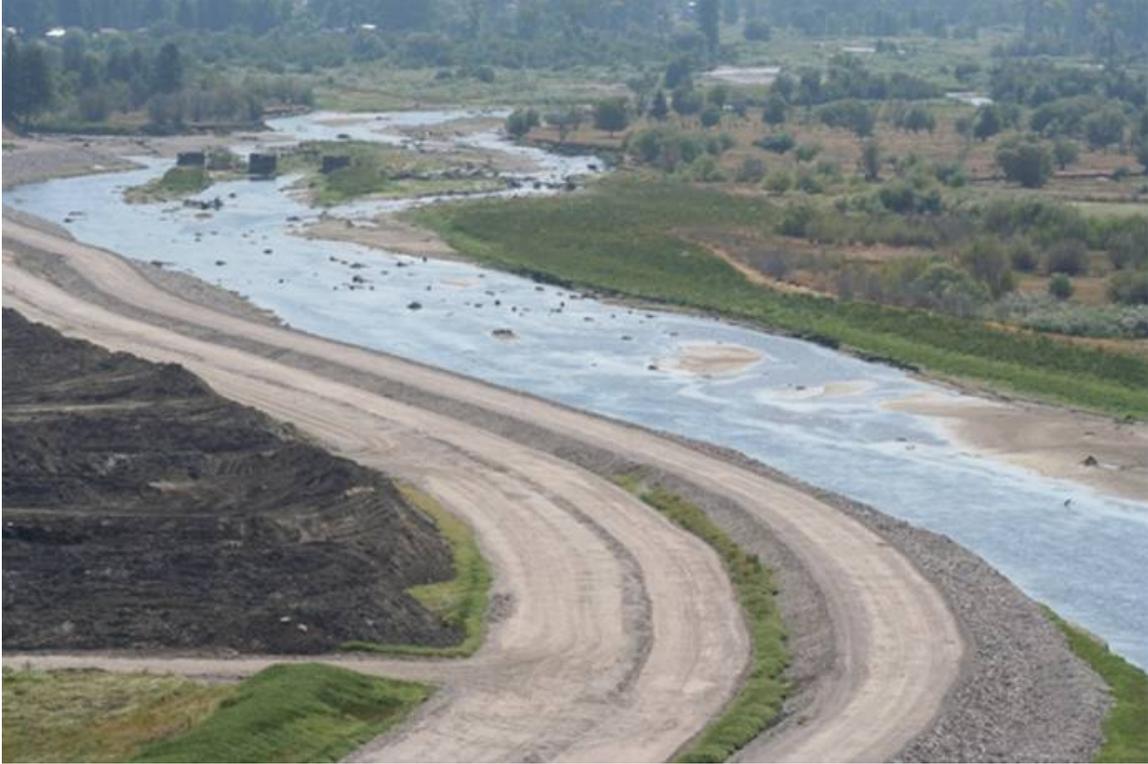
This photo, taken from the bluff, shows the Clark Fork River channel of the reservoir about a mile upstream of the dam. In the channel below the old railroad bridge pilings numerous tree stumps have emerged as the river has eroded down into the channel sediments. These are trees that were cut before the reservoir was filled in 1908. These stumps are at a higher elevation than the stumps found previously in the bypass channel excavation. They probably were on a bench above the original river channel, which was located farther to the north near the Interstate highway. The stumps are emerging in the river just below the old rail bridge, but have not appeared in the channel downstream towards the dam where thick sediment deposits remain.

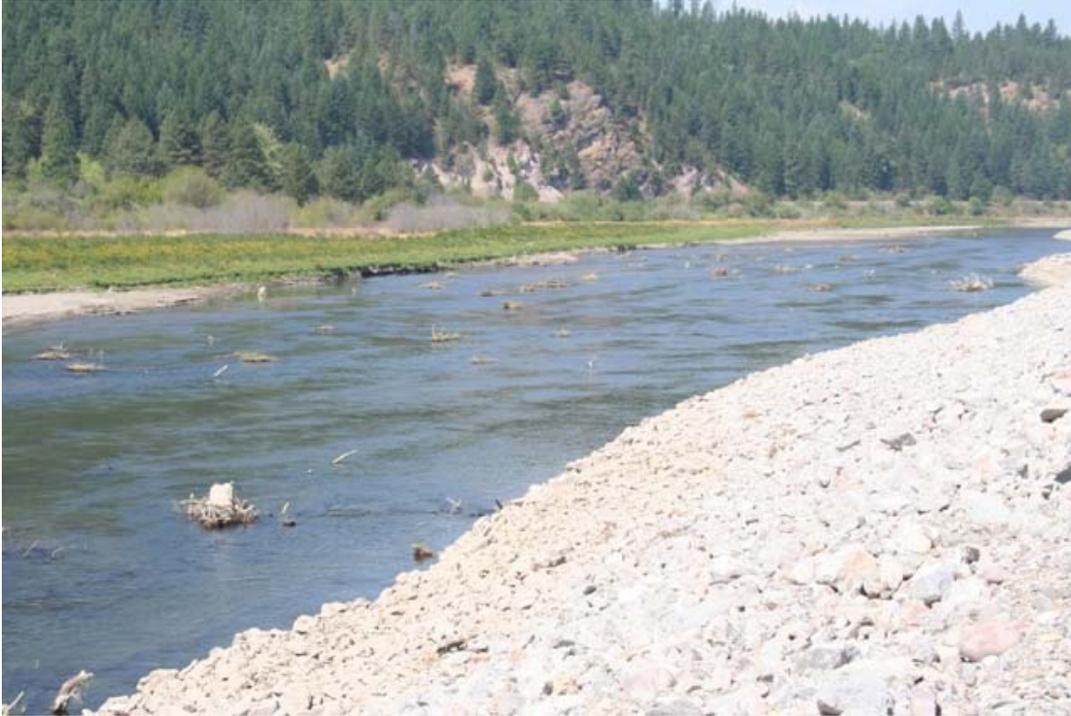
This photo shows another view of the stumps in the channel, taken from the flood berm in Envirocon's construction area.

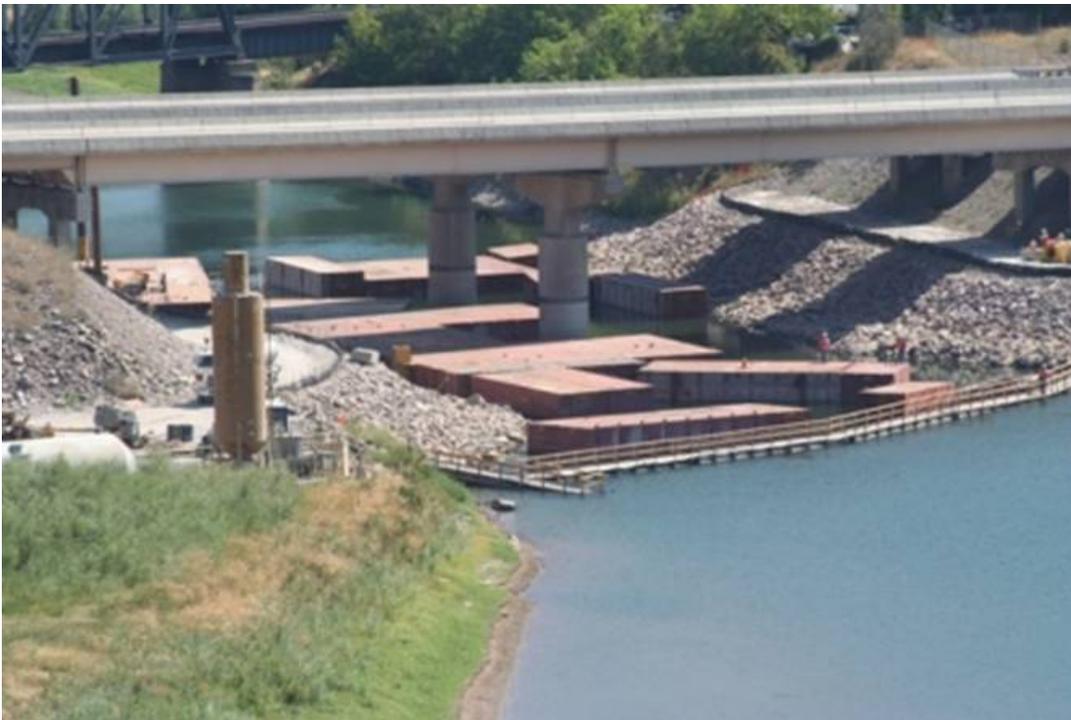
Floating barges are being installed in the river to access the center piers. About 40 barges were installed at the time this photo was taken this week. A total of about 100 of these barges will be installed before work starts on the piers. If you ever wondered why the river has been closed to floaters during the project, this should explain it for you.

The tower on the left bank is for making the concrete used for the jet grouting.

The U.S. Army Corps of Engineers has contracted with several construction companies to stabilize the Interstate highway bridges. Spaulding Construction, of Stevensville, is doing work on the slope stabilization and also completed the removal of timber cribs in the river behind the

Bonner mill. Hayward-Baker is conducting the jet grouting work, in which concrete is injected into the ground in interlocking columns to stabilize the embankments. Hardrive Inc. of Billings is doing the abutment underpinning. Several local companies are also at work: Orion Engineering is doing the geotechnical monitoring on site, Morrison-Maierle Inc. and DJ & A are both doing survey work during the project. Conti Infrastructure and Engineering, of New Jersey, is preparing to complete the pier stabilization. Several subcontractors will be working for Conti, including Becho Inc of Salt Lake City.

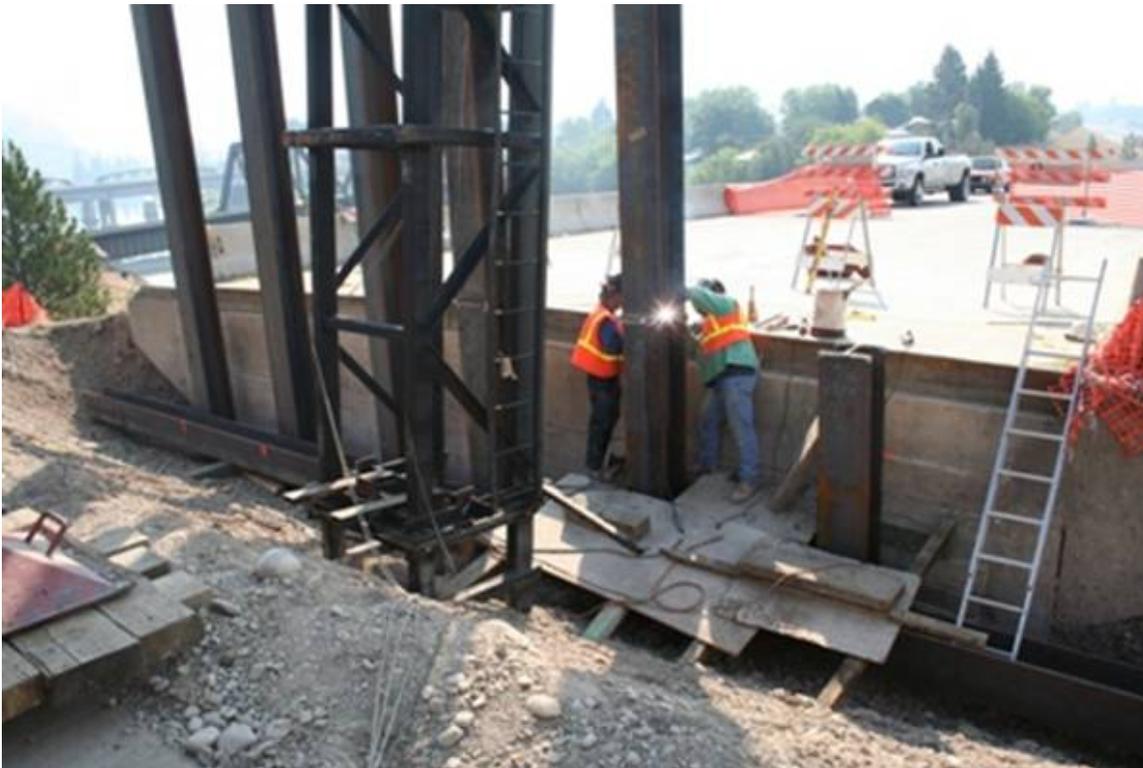
In this photo workers from Hardrive Inc of Billings are welding sections of 16 inch H pile. These piles have been driven down to bedrock at both ends of the Interstate to pin the abutments in place, stabilizing the bridge to withstand flows of the river when the dam is removed. After last week's tragic events in Minneapolis, it is comforting to know that the EPA, Montana Department of Transportation and Corps of Engineers are taking a conservative approach to fortifying these bridges. When the project is complete, the bridges are designed to be stronger and safer than they were before the dam was removed.

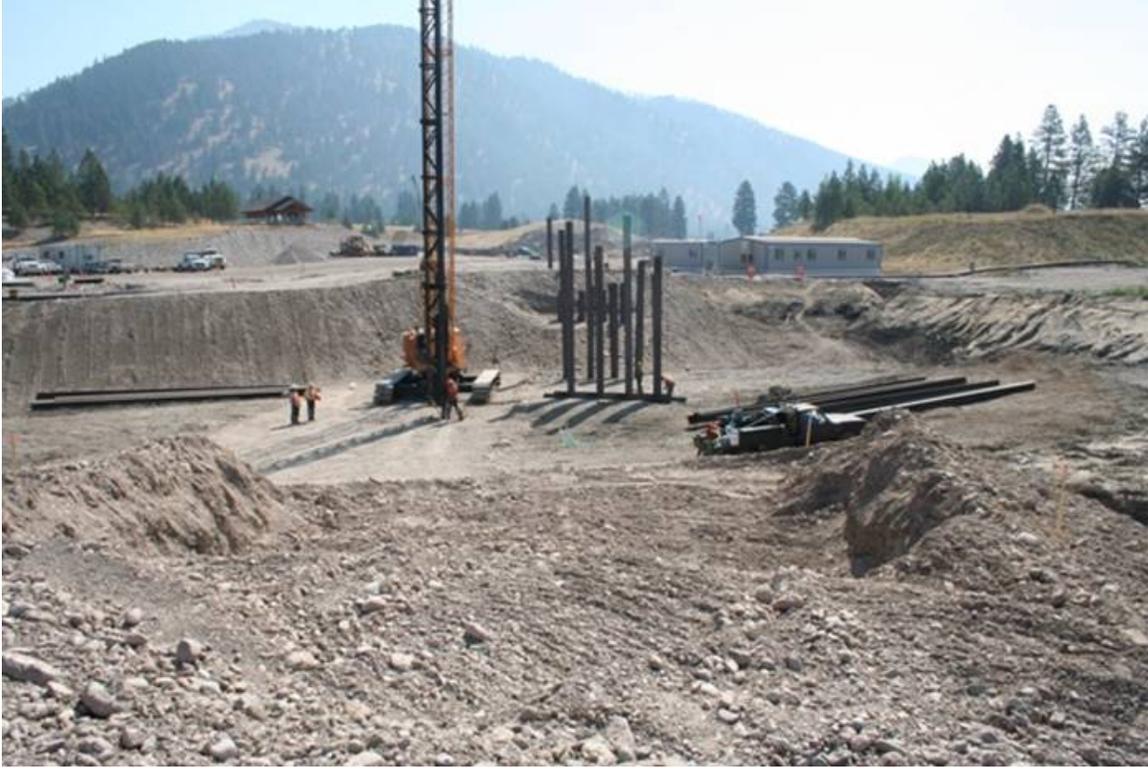
Back at the Envirocon site, a new railroad bridge is being installed over the bypass channel at the upper end of the sediment removal area. A subcontractor to Envirocon is installing steel H piles, which extend about 20 feet down to bedrock and will support the rail bridge girder packs. The rail line will extend out onto the reservoir sediments, where one train per day will be loaded and transported to the BP-Arco waste repository near the former Anaconda Smelter. The current schedule calls for shipping of sediments to begin in October this year.

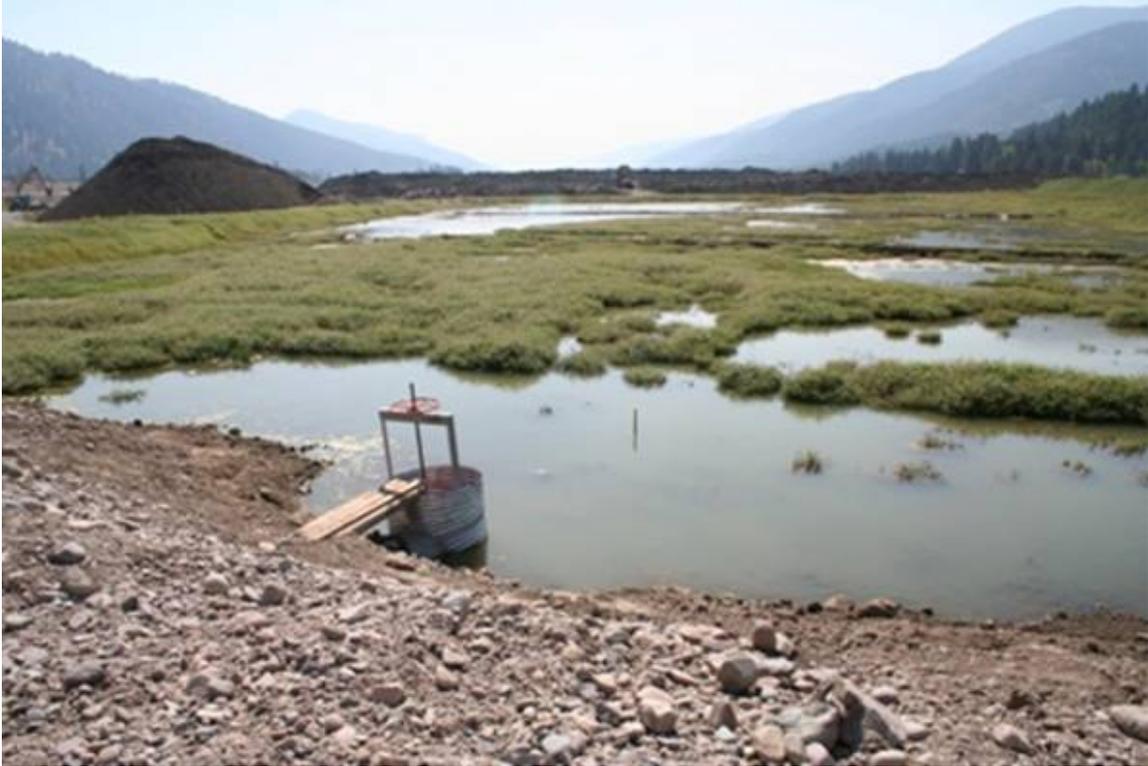
This photo shows the sedimentation pond at the downstream point of the sediment removal area. The pond is full of water, not because we have had any recent rainfall but because Envirocon has voluntarily agreed to route water pumped from the bypass channel dewatering wells to the pond for treatment before discharging it to the river. This relatively simple measure has resulted in remarkably improved water quality going to the river. Until recently, water discharged from wells in the lower reservoir contained about 350 parts per billion arsenic. Arsenic discharge levels were as high as 800 - 900 parts per billion last winter. When the water is routed through the ponds, it is oxygenated and the arsenic settles out. The discharge now contains about 35 parts per billion arsenic, which still exceeds the drinking water standard of 10 ppb but is much cleaner than before. Envirocon was not required to take this measure, because all of the downstream river monitoring indicated compliance with the arsenic standard. But this is one extra measure that can be taken to protect the river and its downstream users, and we appreciate Envirocon's cooperation very much.

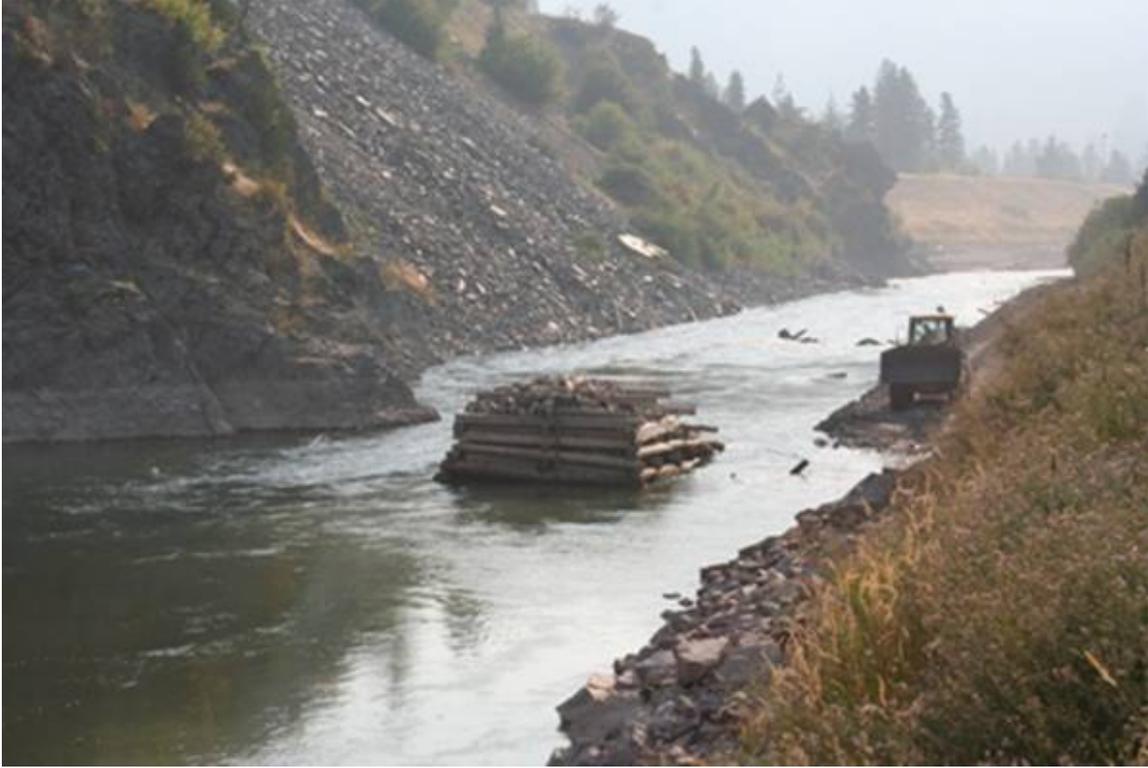
This photo was taken a week ago on the Blackfoot River behind the Bonner mill. The EPA provided funding to remove four of the old timber cribs from the river next to the Stimson cooling pond. This photo shows the last of the four cribs, and a front end loader preparing a road to access the structure on the bank. The removal of these structures will help reduce the potential for ice and debris accumulations next to the cooling ponds next winter and spring, protecting the river from the risk of damage from erosion of the ponds. EPA previously rip-rapped the toe of the cooling pond to provide further protection. The State of Montana removed several thousand old logs from the river last summer, and may remove more this year or next. Thousands of logs remain in the river channel from the days when the river was used to drive the logs downstream. The timber cribs were used to raft the logs up so they could be loaded into the mill. Other timber cribs remain in the river upstream of the cooling pond, at least for the time being. Plans should be made soon to deal with the debris, logs and other items deposited in the river over the years behind the mill. The State will also prepare a restoration plan in the future for the Blackfoot River upstream of the Interstate Highway.

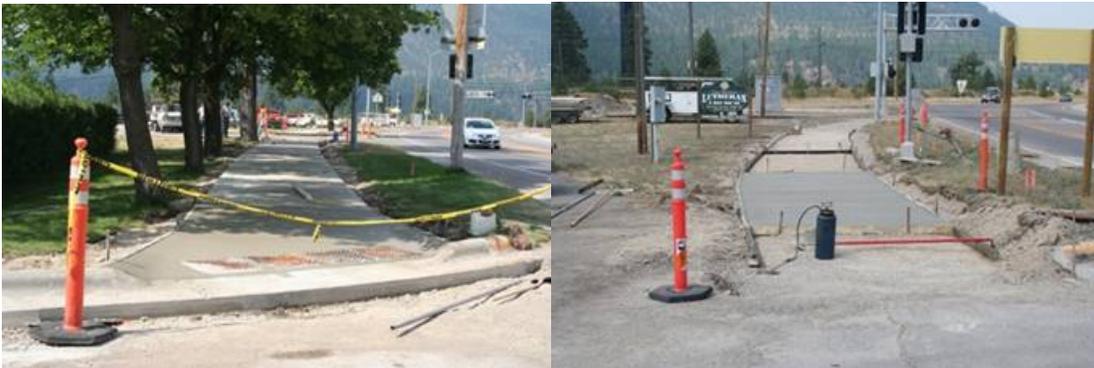
These two photos show the construction of a concrete pedestrian walkway along Highway 200, in front of the Lutheran and Catholic Churches in Bonner. This project, coordinated by Missoula

County, was funded by the U.S. Environmental Protection Agency. Construction is being done by L.S. Jensen Construction of Missoula and the project design and oversight has been done by Territorial-Landworks of Missoula. It will provide a safer route to Bonner and to the Bonner School for residents of Bonner Pines and Piltzville, since their customary route will be closed down by construction of the rail line to the sediment removal area. This walkway will remain as a long term asset to the community long after the dam is removed and the rivers are restored.

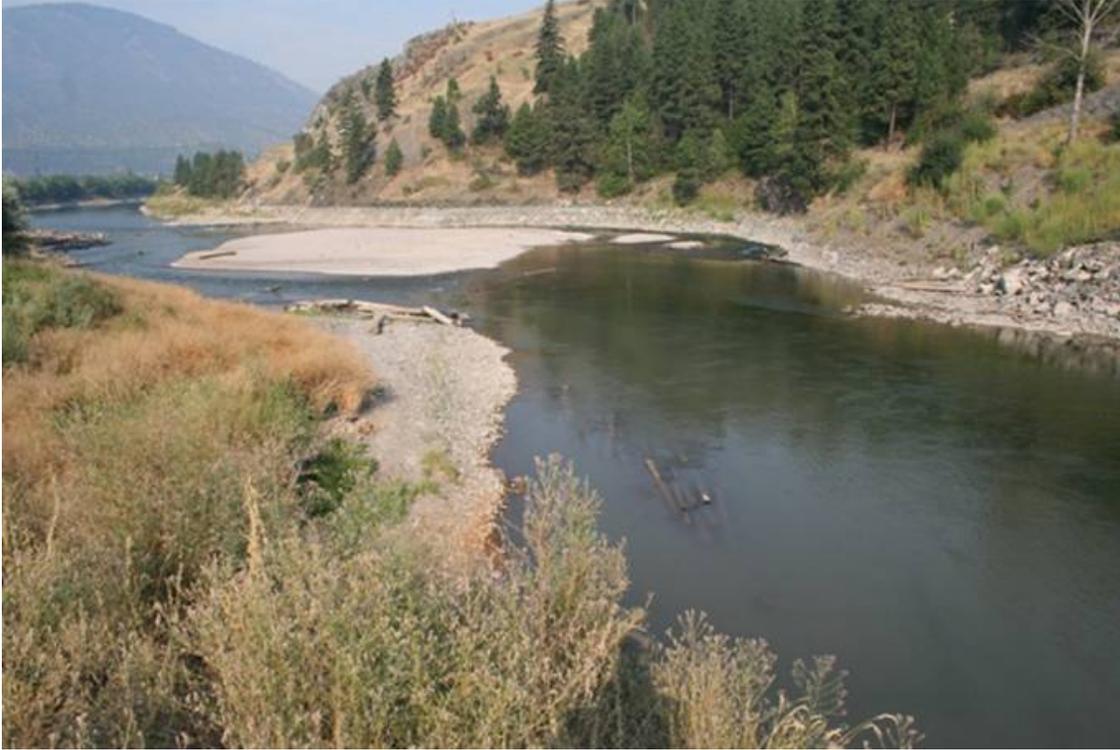
This photo shows the remarkable transformation of the Blackfoot River below the former Bonner Dam. The old dam was located at the narrow point in the river. This photo was taken looking downstream. Just below the old dam, a 30 foot deep scour hole was formed by the hydraulic forces of the river going over the dam. The scour hole has completely filled up with gravel eroded from the river bed upstream. Where a 30 foot deep hole once existed, a gravel bar now has built up five feet or more above the current river level. This process of erosion and redistribution of river gravels and sediments will occur along the Blackfoot and Clark Fork, including downstream of the Milltown Dam once it is removed. It challenges the imagination to envision how the rivers will change over time. We are lucky to have a front row seat to witness these remarkable changes occurring right before our eyes.
