### **Milltown Reservoir Site Update, May 3, 2007.**

Construction work continues at the Milltown Reservoir Site to prepare for springtime high river flows. The Reservoir is currently drawn down 6.5 feet from full pool, up from a maximum drawdown of about 12 feet earlier this winter. The reservoir level rises with increased flow in the river. River flows have increased during the past week, but remain well below normal spring peak flows. Envirocon has completed the Clark Fork flood berm and most of the Blackfoot berm surrounding the contaminated sediments in the lower reservoir.

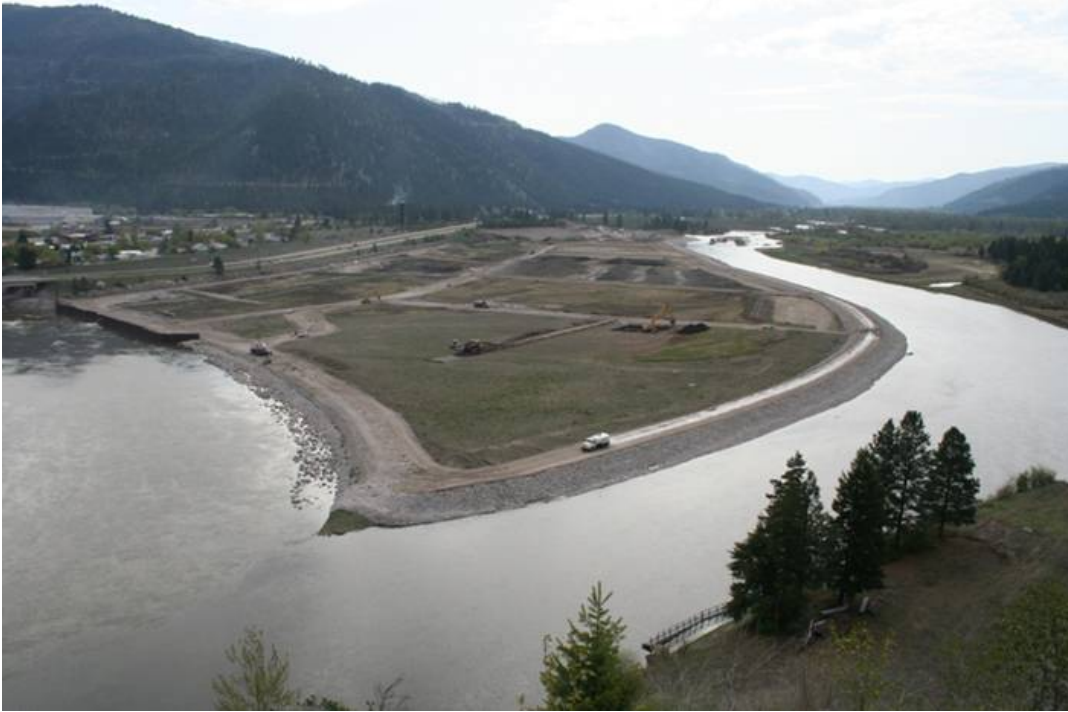
This photo shows an overview of the construction site from the bluff above the dam. A water truck is applying water to the road in the foreground, to control dust. Heavy equipment is excavating a sedimentation pond in the foreground behind the water truck. The Clark Fork flood berm is complete, and a crane is placing large rock along the Blackfoot berm, which is expected to be complete this week.

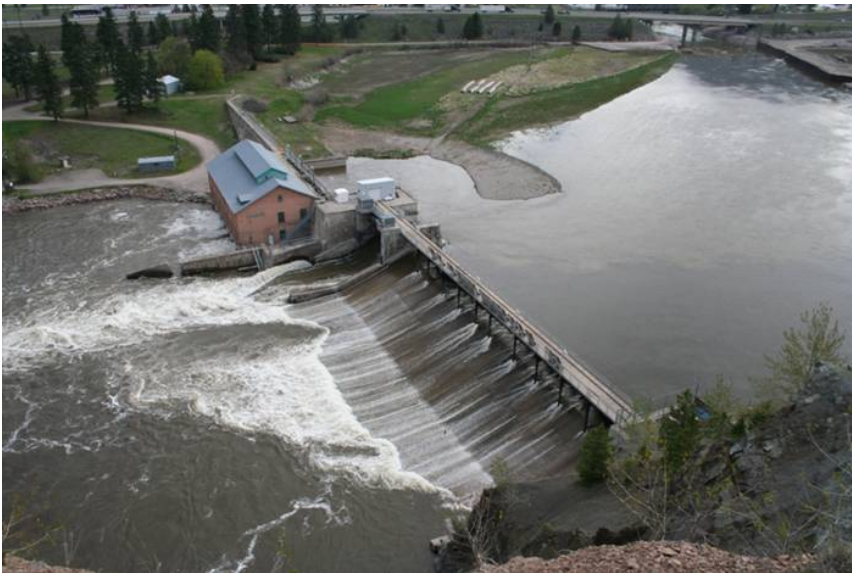
Water is flowing over the spillway of the dam in this photo taken Tuesday of this week. Water is also flowing through the powerhouse outlets, and through the radial gate between the powerhouse and spillway. The flow in the river today is about 8,000 cubic feet per second (cfs). A ten year flood event for the combined flows of both rivers is 25,900 cfs. The flood berms in the reservoir are sized to protect against the ten year flood event, with an additional two feet of

freeboard for additional safety. In addition, the removal of the turbine equipment and routing of flows through the powerhouse provides significant additional flood protection. Unless we receive very heavy rains this spring it is very unlikely that we will get close to a ten year flow in the rivers this year.

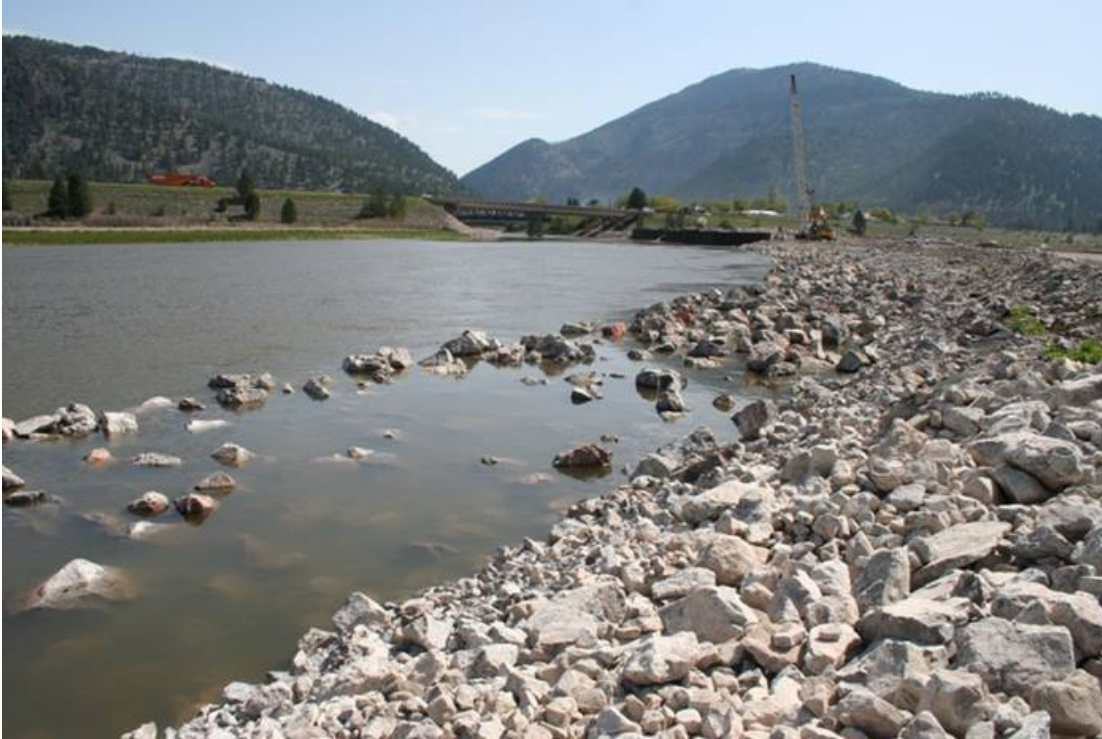
This photo shows large rock riprap placed along the Blackfoot flood control berm. Much of this rock will drop or be “launched” into place below water level when high river flows erode some of the finer grained reservoir sediments below the rock. The berm will look a bit different in July after the rivers drop to summertime flows.

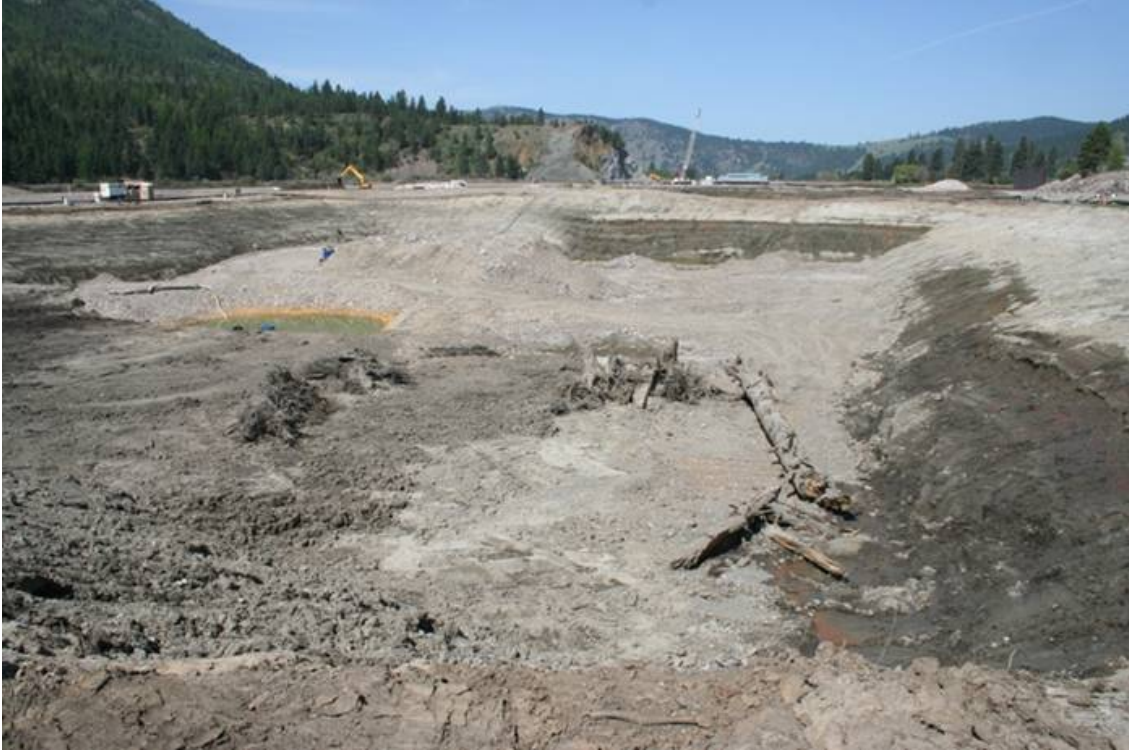
This photo shows the excavation area for the bypass channel. The excavation is about 25 feet deep, and the channel will be 100 feet wide at its base. Note the darker color of sediments in the bank on the right, where water is seeping into the pit. Logs and stumps have been uncovered at the bottom of the pit. Water level in this excavation is being reduced by pumping from a series of large wells, which discharge directly to the Blackfoot River. A small deeper pit in the upper left hand corner of the pit is where water has been pumped to test the effectiveness of this method as compared to using the large wells next to the pit. EPA and other agencies are currently reviewing updated plans for dewatering the bypass channel excavation, and a contingency plan for treatment of water from the excavation if downstream water quality exceeds standards for arsenic or other contaminants. Excavation of the bypass channel will continue in May or June, with completion by this fall before the next 6 foot reservoir drawdown.

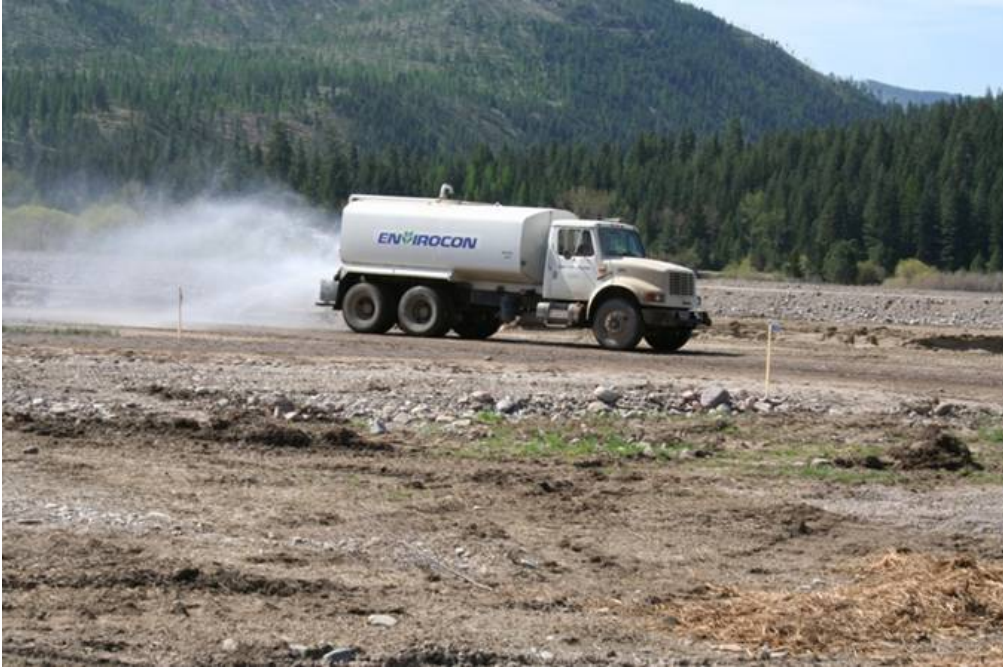
Envirocon controls dust emissions from their roads and disturbed areas with this water truck. A more long-lasting treatment of magnesium chloride dust control will be applied to the main access road into the site, closest to the residential areas of Pittsville and Bonner Pines. Dust from the on-site roads is not contaminated with arsenic or heavy metals, the main concern is particulate pollution. Contaminated sediments stockpiled on site may also be treated hydroseeded and/or sprayed with water to limit wind erosion. So far the sediments are much too wet to be eroded by the wind. With a few exceptions, dust has not been a problem at the site since the project began. On one recent windy day dust was observed coming from on site roads and blowing near the Interstate highway. Envirocon responded quickly by re-applying water to the roads. Dust was also a problem when truck hauling started this spring to bring rock along Rustic Road, just upstream of Piltzville. The Montana Department of Transportation responded quickly and swept the road to remove remnants of wintertime sanding material from the road. EPA and DEQ have established a no visible dust standard for the construction project.

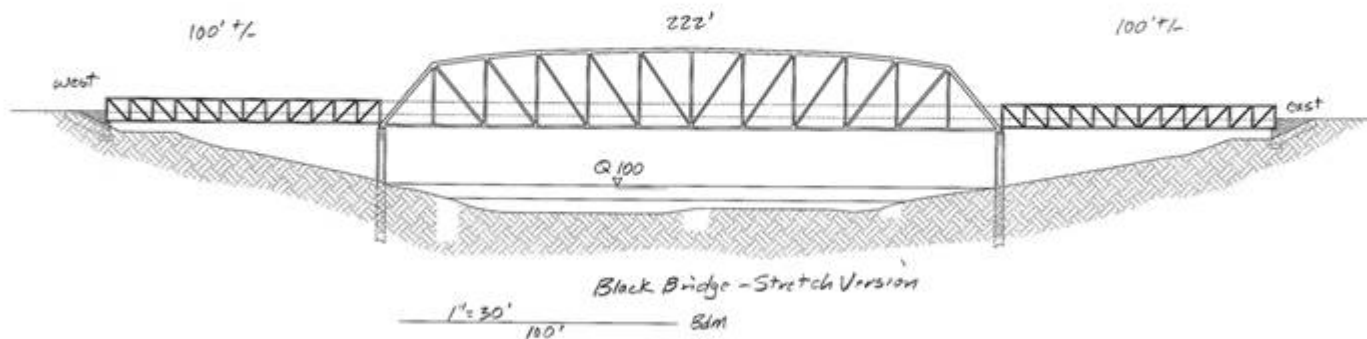
The drawing above shows the proposed design of the pedestrian bridge over the Blackfoot River. (See attached pdf file for more detailed color version) This bridge is owned by Missoula County. It will become unsafe when the dam is removed a year from now, and must be either upgraded or replaced. Missoula County received approval of a \$975,652 grant from the Montana Natural Resource Damage Program in 2006 to complete this project. It was approved by the Governor in December. Shortly after that, the State decided to replace the highway 200 bridge, just downstream of the pedestrian bridge. The Natural Resource Damage Program put the County's grant on hold, and required an amended grant proposal to address the highway 200 decision, since the new highway bridge will include at least one 5 foot pedestrian walkway. The County's proposal will be considered by a Citizen Advisory Council on Tuesday, May 8, at 2 p.m. at the St. Ann's Catholic Church in Bonner. After hearing public comment, the council will vote on the proposal. Unfortunately, the program staff has recommended against funding the proposal, primarily because it will cost an additional \$700,000 compared to the cheapest alternative considered. Program staff believe that these funds should be applied to other projects. But the County is not requesting any additional funds from the State. The additional funds would come from the U.S. Environmental Protection Agency, thanks to Montana Director John Wardell, and from the Federal Highway bill funds secured by Senator Max Baucus. Total cost of the project is estimated at \$2.3 million, with less than half provided by the Natural Resource Damage Program.

- Maintain a separate, safe and desirable multi-use bridge crossing
  - The new bridge would be suitable for multiple uses, including pedestrians, bicyclists, persons with disabilities and other non-motorized users. The

new bridge would be 12-18 feet in width compared to 5 foot width of the walkway on the highway 200 bridge. The 5 foot Highway 200 walkway would not be suitable for multiple uses.
