Weekly Update

Milltown Reservoir Sediments Superfund Site

Issue #59

May 28, 2008

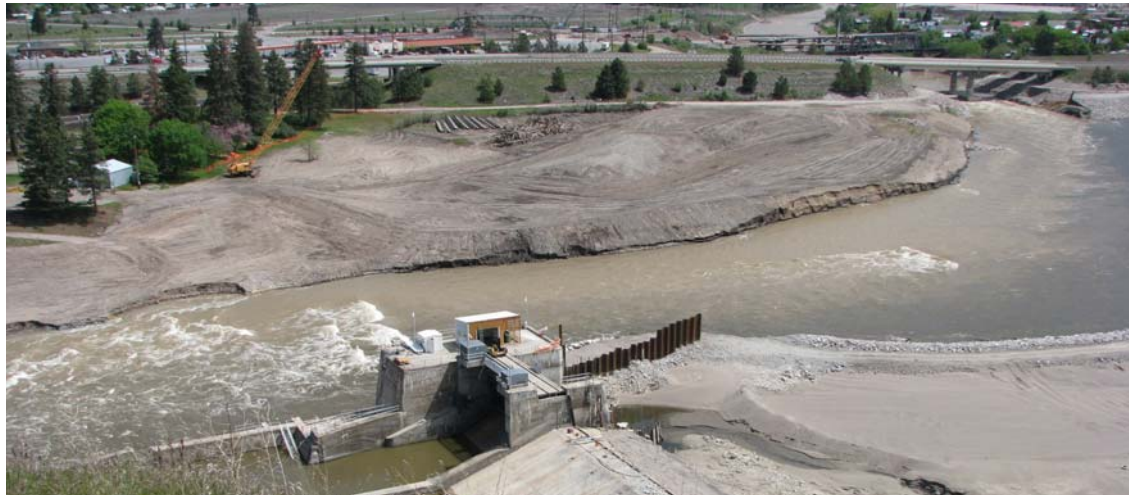
View of the confluence of the Clark Fork and Blackfoot Rivers. Workers are beginning to remove items located on top of the Divider Block in preparation for removal of the remainder of the Milltown Dam. Photo taken May 28, 2008.

- **Beginning to take items off the divider block of the Milltown Dam in preparation for its removal.** Pending EPA and DEQ approval of the workplan, demolition of the Divider Block could early next week. Removal of the Divider Block, Radial Gate, and Spillway will take about five months to complete. **The Milltown Dam should be completely out this fall!**

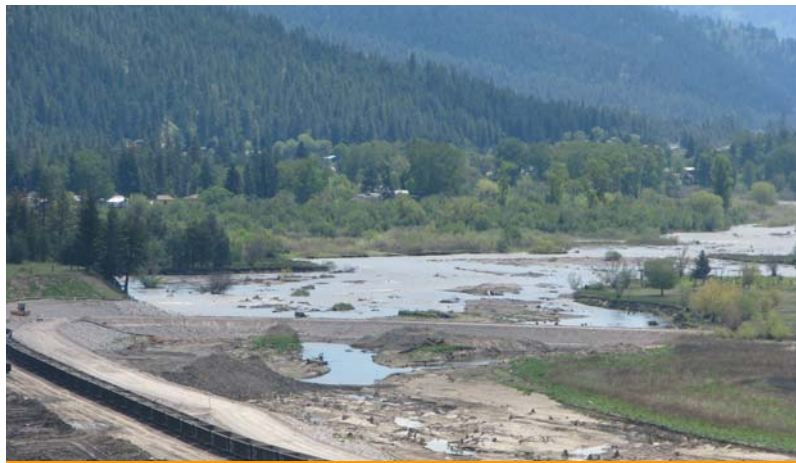
Upstream of the cleanup area the Clark Fork River is changing as stream material is eroded and re-deposited. The former river channel is drying up behind the diversion dike.

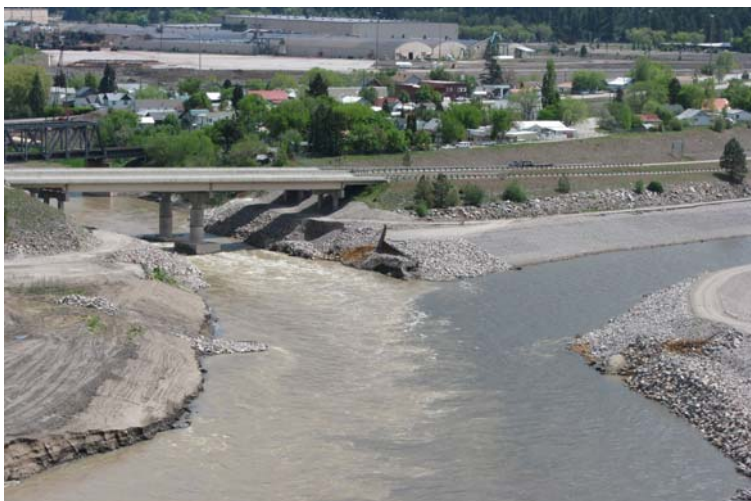
Note the clearer Clark Fork River water flowing from the bypass channel, mixing with the sediment-laden water from far upstream on the Blackfoot River.

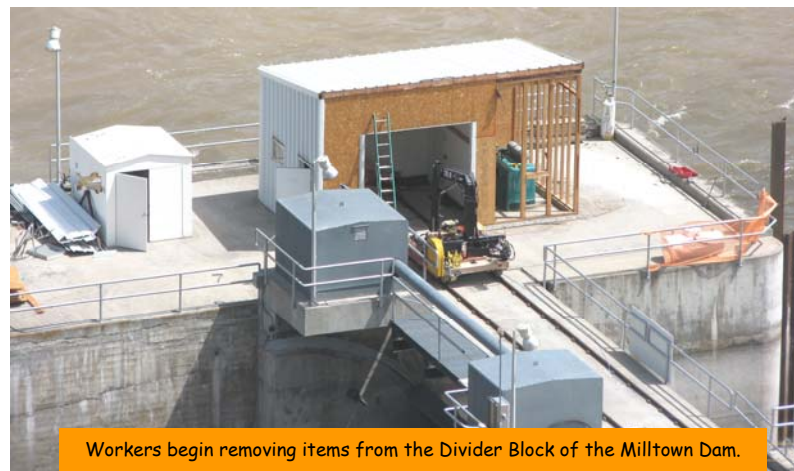
Workers begin removing items from the Divider Block of the Milltown Dam.
