Milltown Reservoir Project Update - October 3, 2007

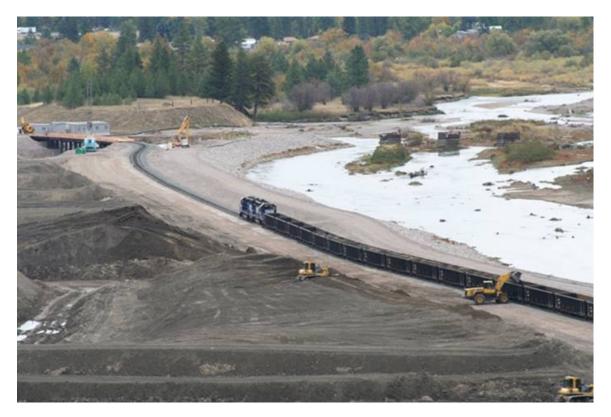
The first train has been loaded with contaminated sediments from the Milltown Reservoir and shipped to the tailings ponds near the former Anaconda Smelter. It has been 99 and one-half years since the mine and smelter tailings were washed downstream from Silver Bow Creek during the 1908 flood. Twenty-six years after arsenic pollution was found in Milltown's water supply, some of the pollution is now being removed from the Milltown site.

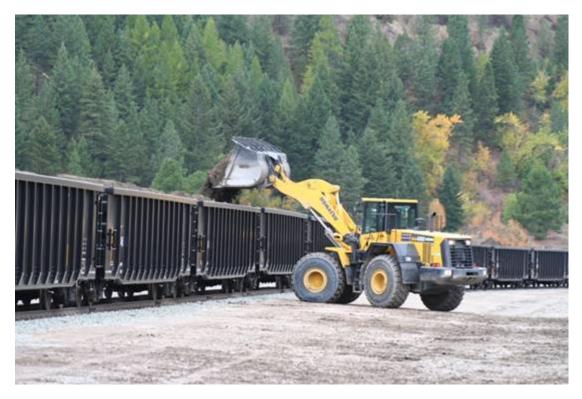
The first train load consisted of 28 rail cars, each containing about 70 cubic yards (100 tons) of reservoir mud. Envirocon, Arco's contractor at the site, estimates that it will take 800 days to transport all of the 2.2 million cubic yards to be removed from the reservoir. The current plan is to ship about 25 cars per day, which will increase to about 45-50 cars per day within the next two weeks. Sediment shipping will continue seven days a week, with a few breaks for holidays. Only about a third of the sediment in the reservoir will be removed and shipped to the Anaconda site. About two-thirds of the 6.6 million cubic yards of reservoir sediment will remain in place or be eroded downstream when the dam is removed.

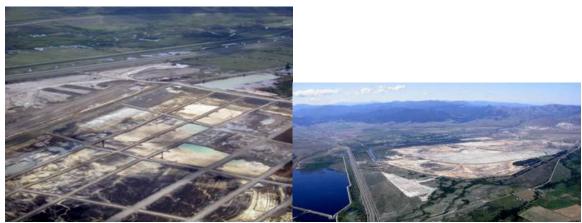
Envirocon will unload the rail cars at the former tailings ponds each day. The photos above show an aerial view of the 3,400 acre tailings ponds, known as the BP-Arco Waste Repository and formerly known as the Opportunity Ponds. The photo on the right is looking southeast as you travel I-90 toward Butte from Missoula. The tailings ponds are located to the right of the Interstate highway, extending all the way from I-90 up to the Anaconda Smelter. They are called ponds, but don't contain much water. These tailings ponds are not visible as you travel on the Interstate highway. The Warm Springs Ponds are on the left side of the freeway, and are not where the sediments will be taken. The sediments will be unloaded into 40 ton haul trucks, and spread on the east side of the tailings ponds in layers up to two feet thick. Eventually the surface will be seeded with a grass seed mix to limit water infiltration into the ponds and help prevent the troublesome dust that swirls around the ponds when it gets windy. The tailings ponds contain about 300 million cubic yards of tailings, so heavily contaminated with arsenic and copper and so acidic that you can't grow grass on it. The Milltown waste will add less than 1% to the volume of mine waste in the tailings ponds.

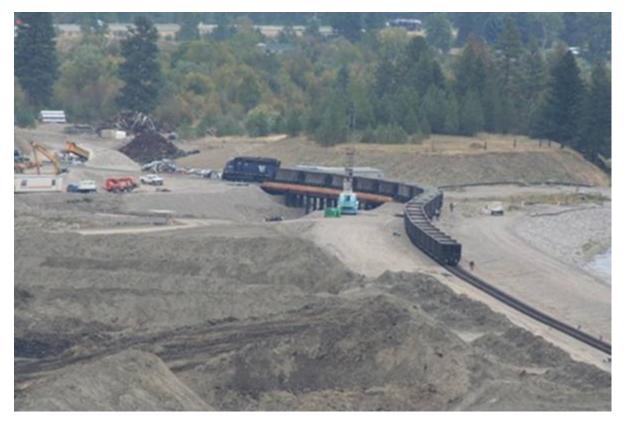
The photo above shows one of the first trains crossing the new rail bridge over the bypass channel, about one mile upstream of the dam, on September 20. This train hauled rock ballast to complete the rail line installation in the sediment removal area.

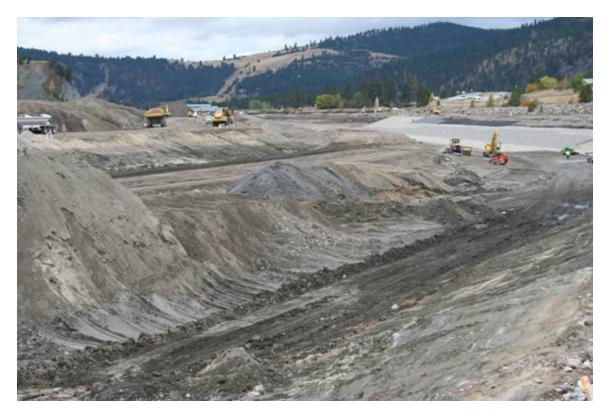
The photo above shows the excavated bypass channel, looking downstream from a point near the new rail bridge. The channel is almost completely excavated. The roof of the dam's powerhouse is visible in the upper left hand corner of the photo. Also visible is the rock liner installed along the Interstate highway embankment. The river may be diverted into the bypass channel in late 2007 or early 2008, when the dam's powerhouse is removed. It will remain in the bypass channel until all of the contaminated sediments are removed and a new meandering river channel is constructed and vegetated through the sediment removal area.

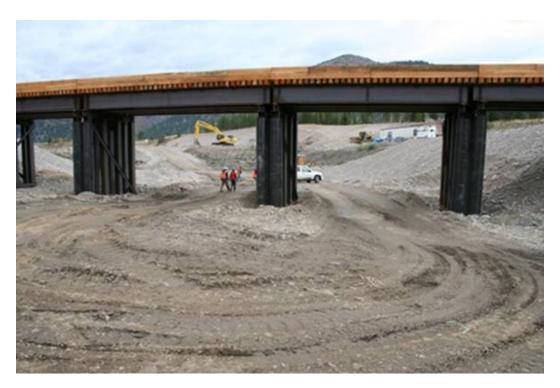
The bypass channel will be diverted from the current Clark Fork arm of the reservoir just upstream of the point where this picture was taken. It will flow under the bridge through this channel.

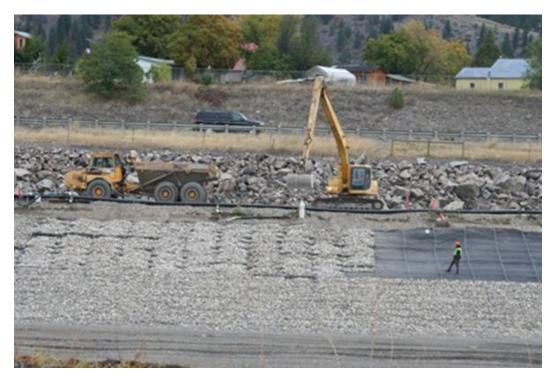
An Envirocon subcontractor from Havre is placing rock and synthetic liners in the channel, which is sized to handle the 100 year flood following dam removal. The rock liner is placed in "reno mattress", which are flat, rock-filled wire baskets.

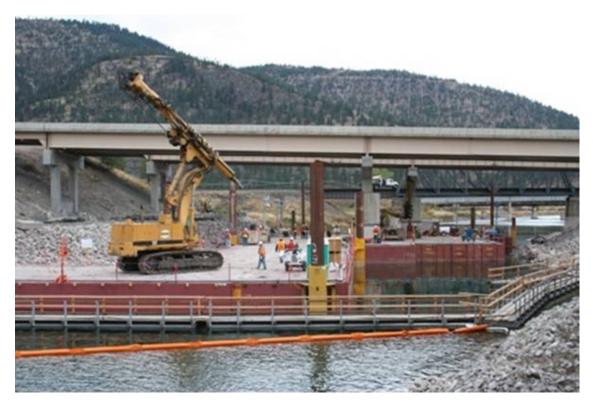
This photo shows the work coordinated by the EPA and Corps of Engineers at the Interstate highway bridges. A large drill is being transported out onto the barges to drill new concrete shafts around the existing center piers. Work also continues on jet grouting along the embankments under the bridges. Crews will begin working 24 hours a day next week. This work must be completed prior to the next reservoir drawdown and powerhouse removal.
